Yaw control problems and runway overrun, Fokker F27-500, G-BNCY

Aircraft Accident Report No: 4/99 (EW/C97/12/1)

Report on the accident to Fokker F27-500, G-BNCY at Guernsey Airport,
Channel Islands on 7 December 1997

Aircraft Type and Registration: Fokker F27 Mark 500, G-BNCY

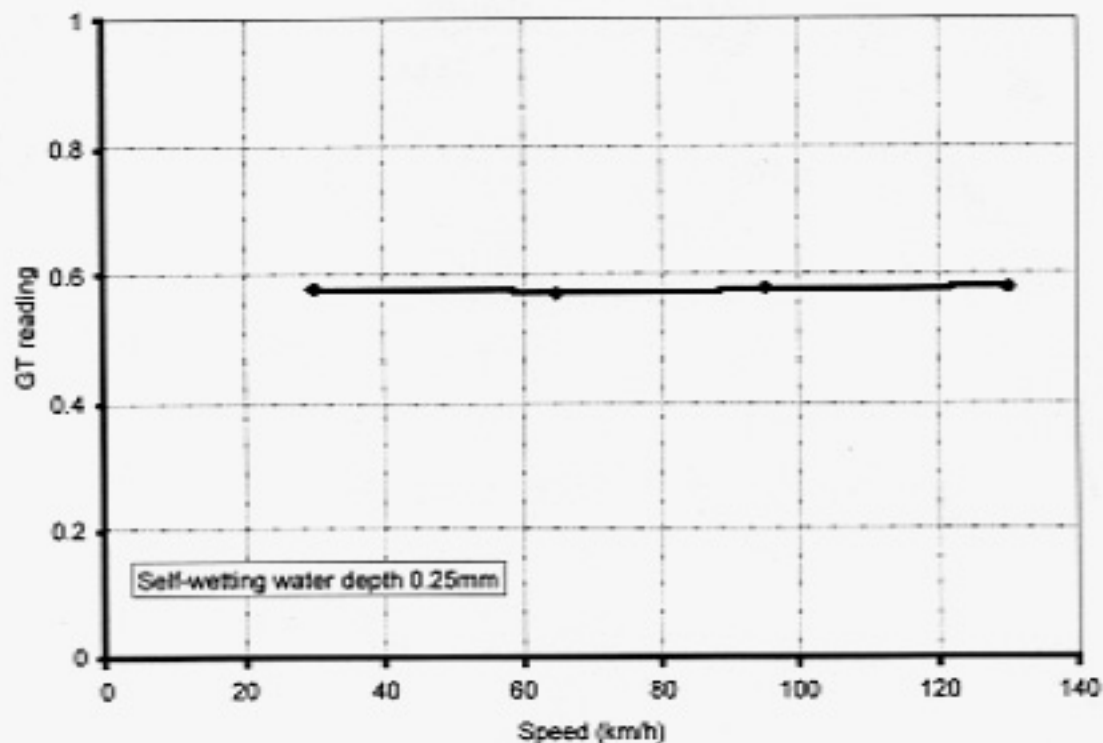
Figure 4 Speed/friction curve runway 09/27

The speed friction/curve for runway 09/27 is presented in Figure 4. A single 500m run 6m from the centreline was made at each of the speeds 30, 65, 95, and 130km/h. The curve remains essentially flat, but at a fairly low level. This indicates that the surface is providing good water clearance beneath the GT measuring tyre, but that the aggregate is polished and has a low microtexture.

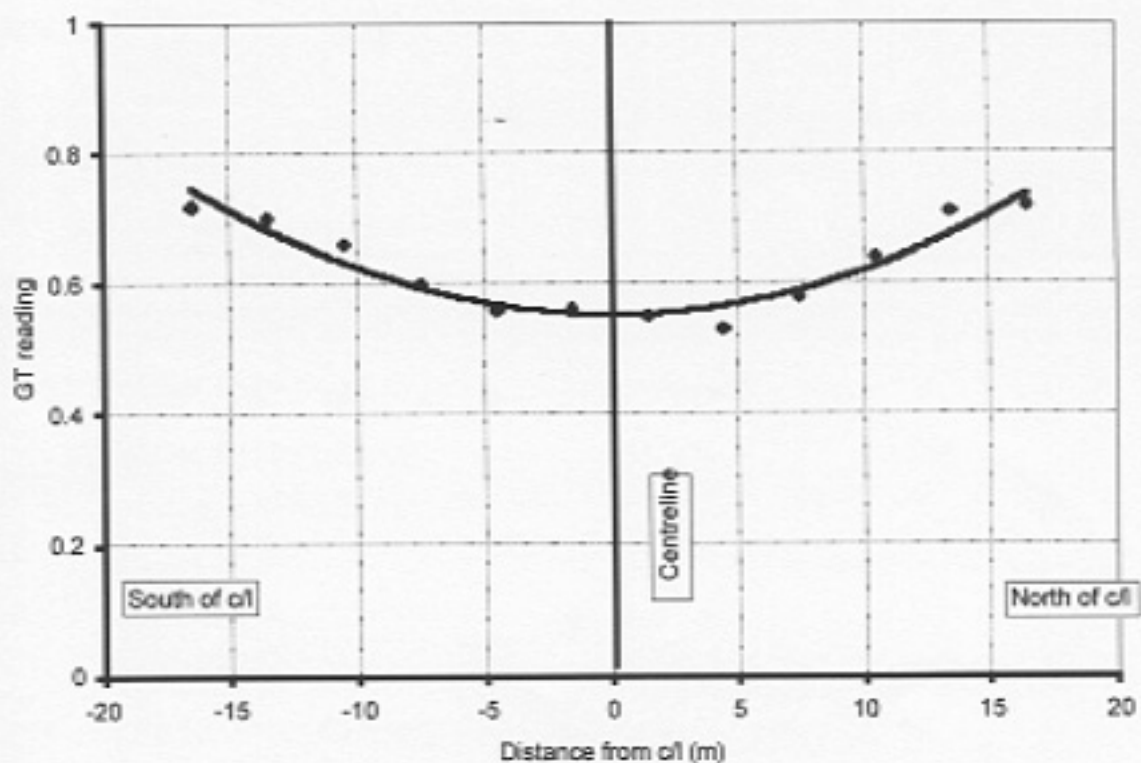
Figure 5 GT reading v Distance from centreline runway 09/27

Figure 5 is a graph showing the variation in average 65km/h full-length self-wetting GT reading with distance from the runway centreline. It can be seen that the readings show a marked variation across the width of the runway, with a rise at the untrafficked edges of the runway, where the aggregate is less polished.

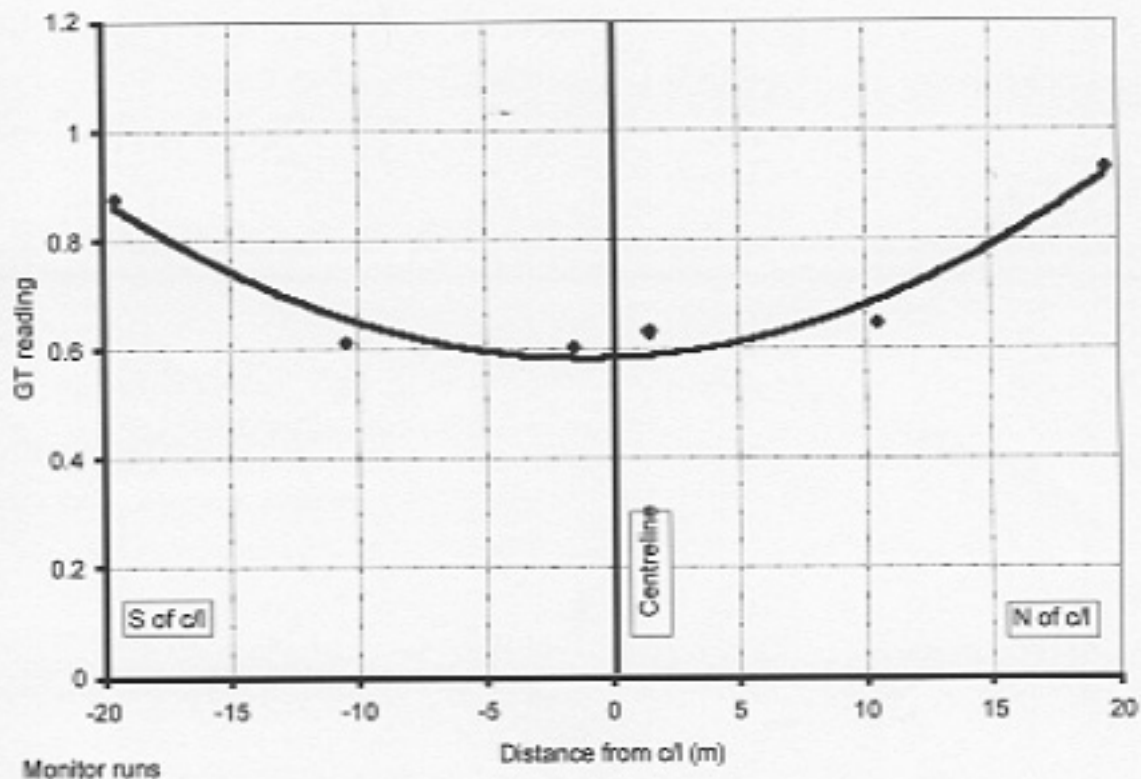
Figure 9 Natural rain. GT reading v Distance from centreline runway 09/27

The shape of the graph of friction reading against distance from the centreline, Figure 9, mirrors that obtained during the classification trial, Figure 5. The increase in friction toward the runway edges is more marked.
