Wing strike, Boeing 757-200, G-WJAN

Air Accident Report No 3/99

Report by the Dominican Republic Authorities into the accident to Boeing 757-200, G-WJAN at Puerto Plata Airfield, Dominican Republic on 1 January 1998

Registration: G-WJAN

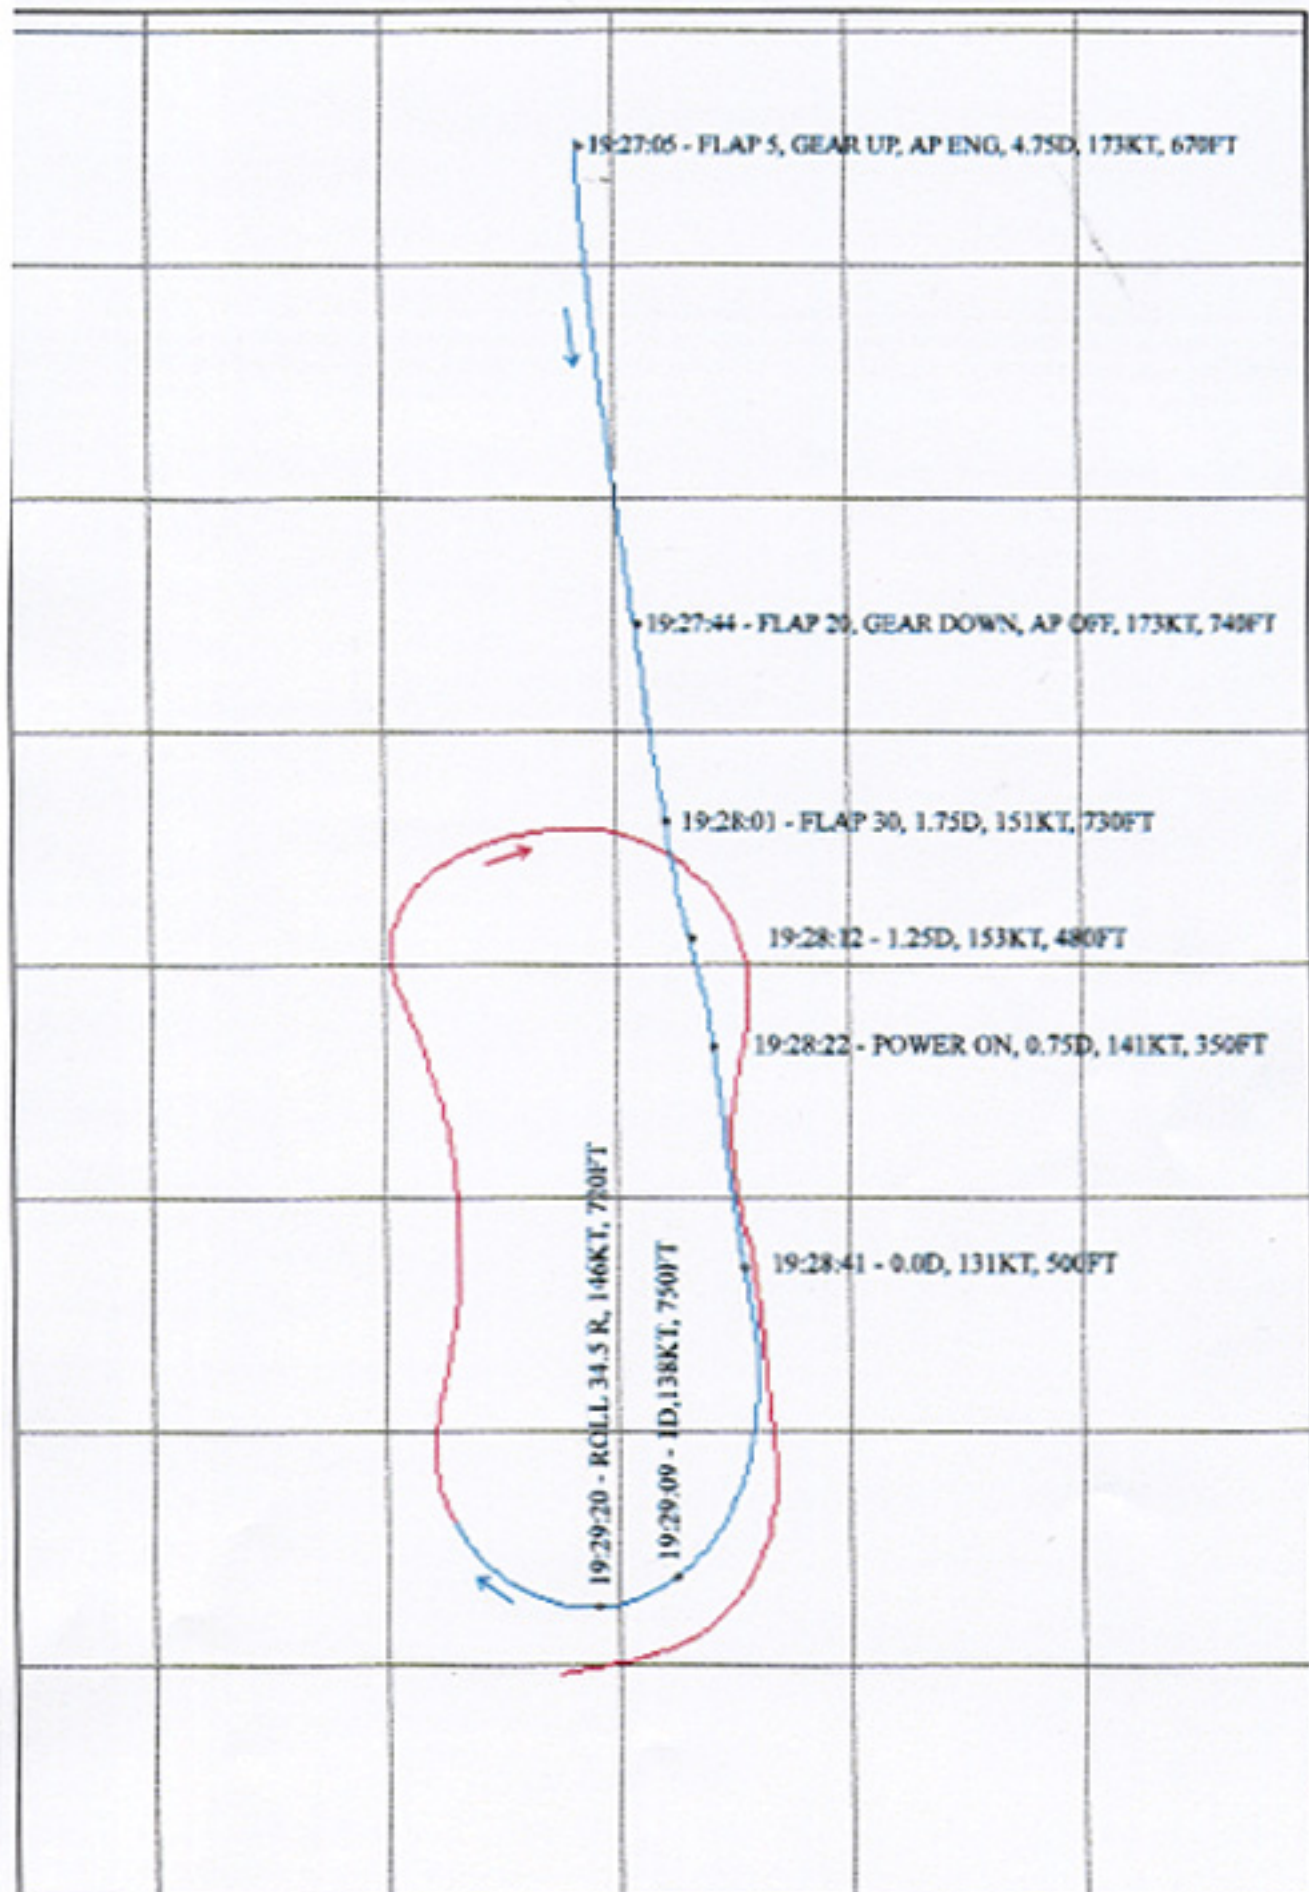
Second missed approach (ground track)

During the second VOR/DME approach the commander failed to configure the aircraft in accordance with the SOPs thus making a successful landing unlikely.

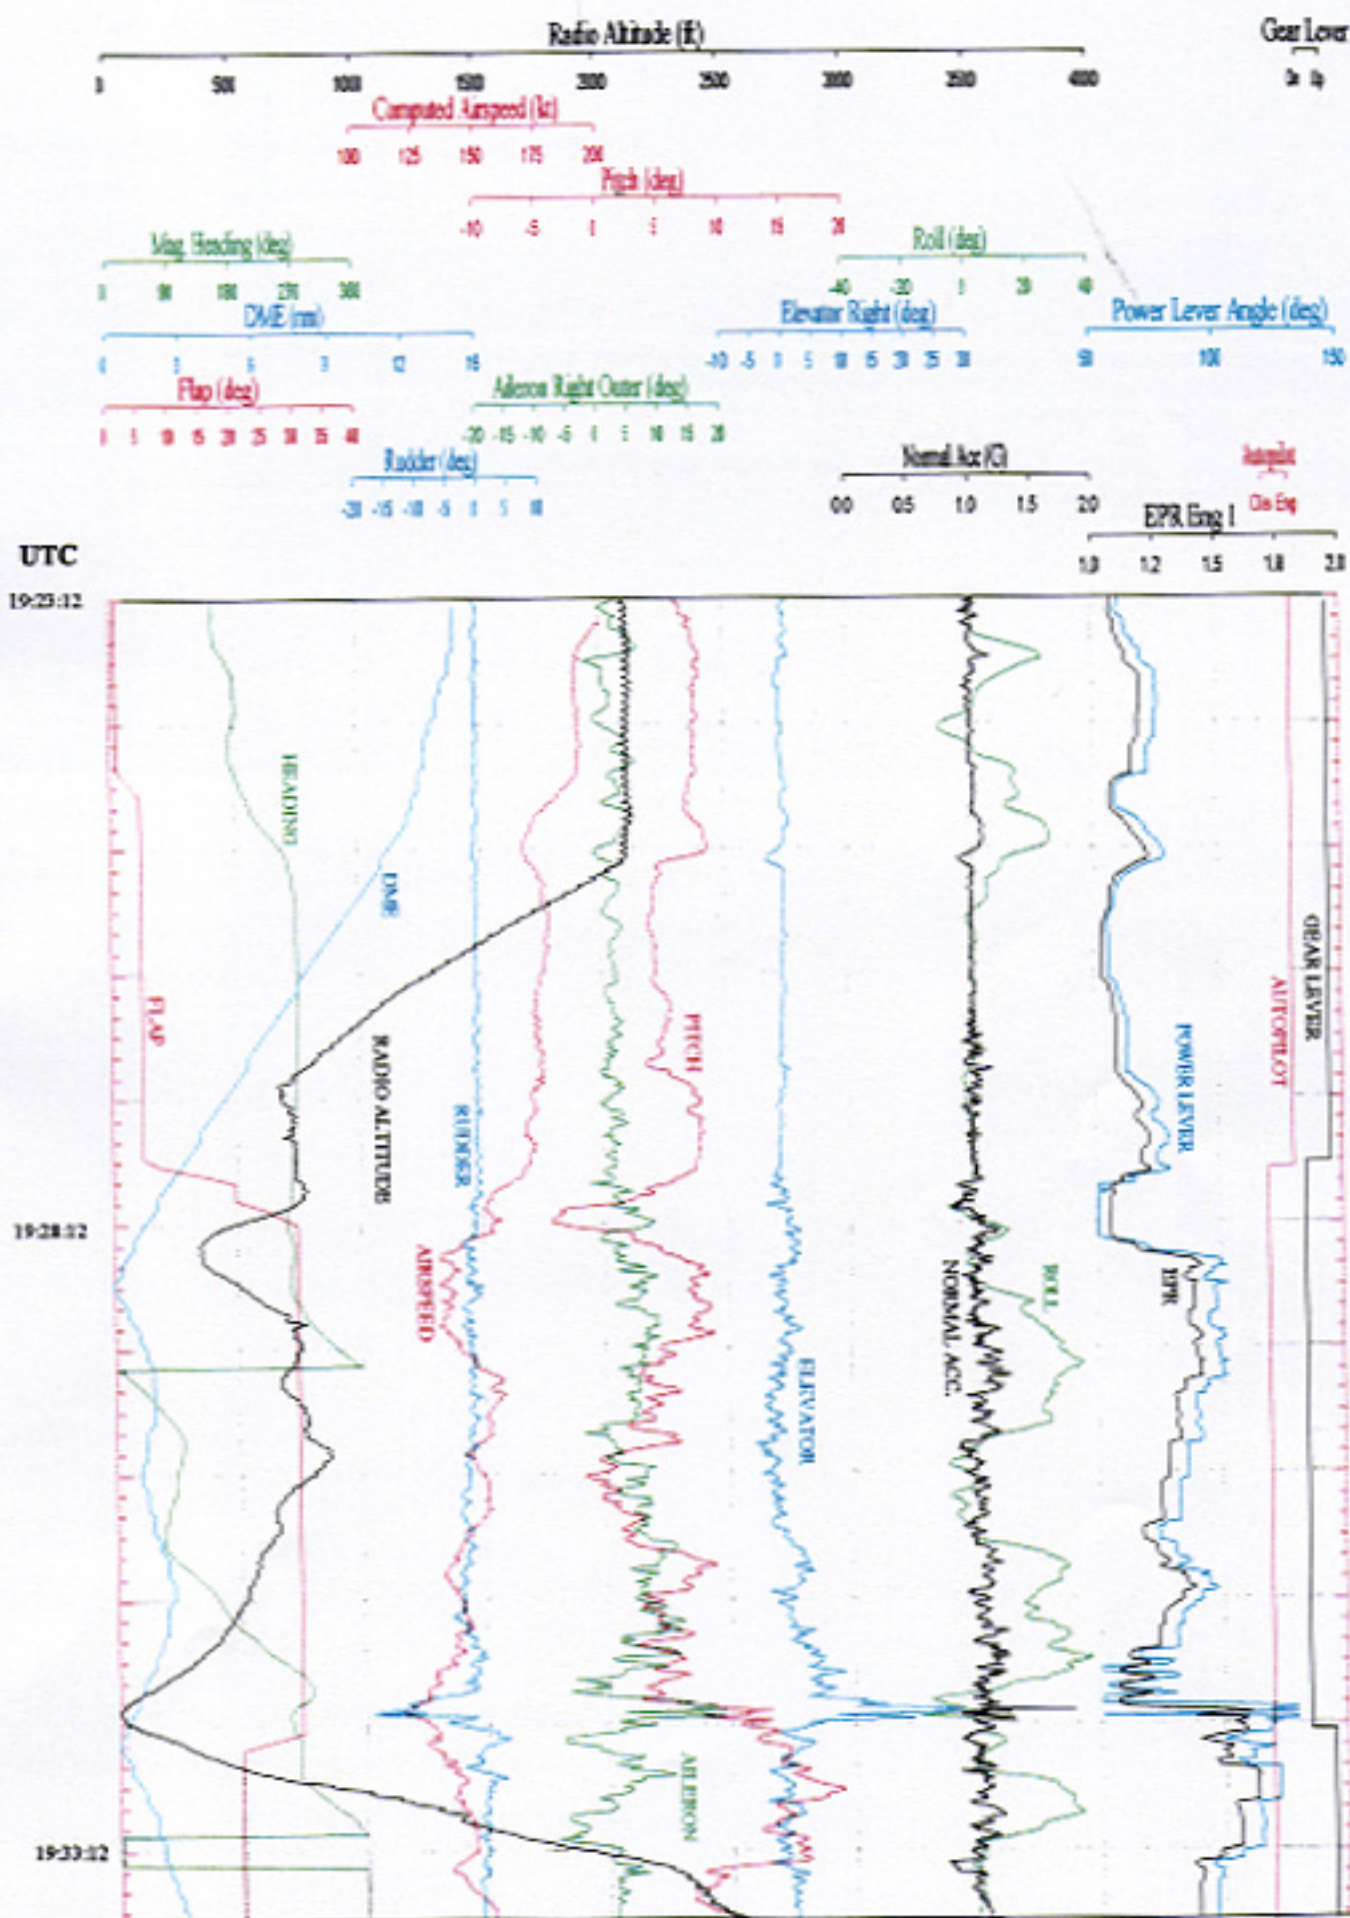
Second and third approach (time history)

- (i) A very late go-around, initiated at a speed 14 kt below the target threshold speed, resulted in the underside of the aircraft's tail striking the ground thereby causing considerable damage to the aircraft.
