In-flight smoke, Boeing 757-236, G-CPER

Aircraft Accident Report No: 3/2005 (EW/C2003/09/01)

Aircraft Type and Model: Boeing 757-236

Registration: G-CPER

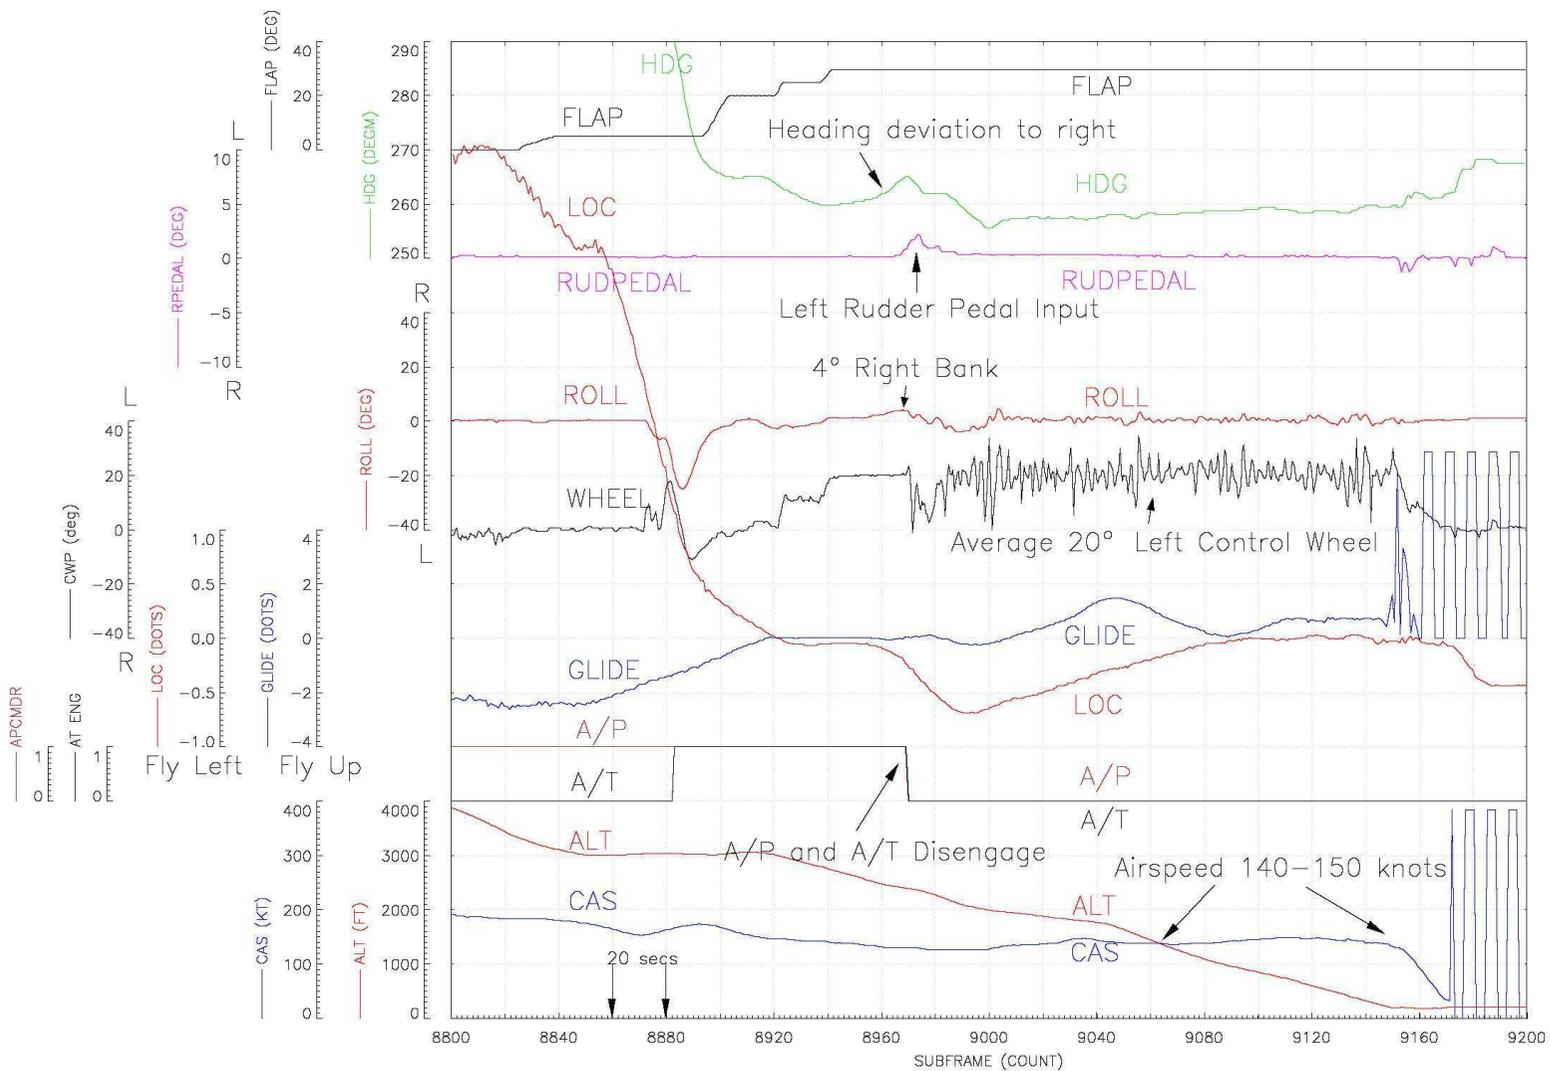
Figure 7
 Relevant Flight Recorder Parameters for Approach and Landing
 at London Gatwick

A time history of the relevant flight parameters during the approach to Gatwick is shown in Figure 7. This shows that the approach was normal until the final stages of flap were lowered. When 25° and 30° of flap were selected the autopilot applied about 12° and 20° of left control wheel respectively. The latter control input was insufficient to stop a slight bank angle of approximately 4° to
