## Left MLG fire on landing, Boeing 777-200ER, AP-BGL

**Micro-summary:** While taxiing after landing, the left main landing gear was observed to be on fire.

**Investigative Body:** Aircraft Accident Investigation Board (AAIB), United Kingdom

**INCIDENT**

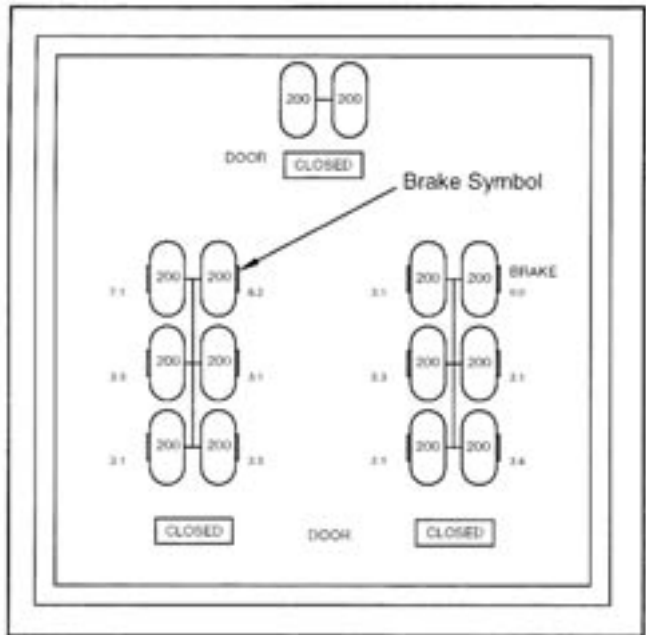
**Figure 2**

Each of the two MLGs on the Boeing 777 has six wheels on a three axle truck, each wheel being equipped with a hydraulically actuated multi-disk carbon brake. They are numbered across the aircraft, No 1 wheel being the front left unit on the left MLG, No 12 being the right rear unit on the right MLG. Each main wheel is also fitted with a thermal wheel fuse plug, a thermocouple, a wheel speed transducer and pressure transducer. The brake temperature and tyre pressure is displayed on the landing gear synoptic and brake and steering maintenance pages, see Figures 2 and 3.

Landing Gear Synoptic Display

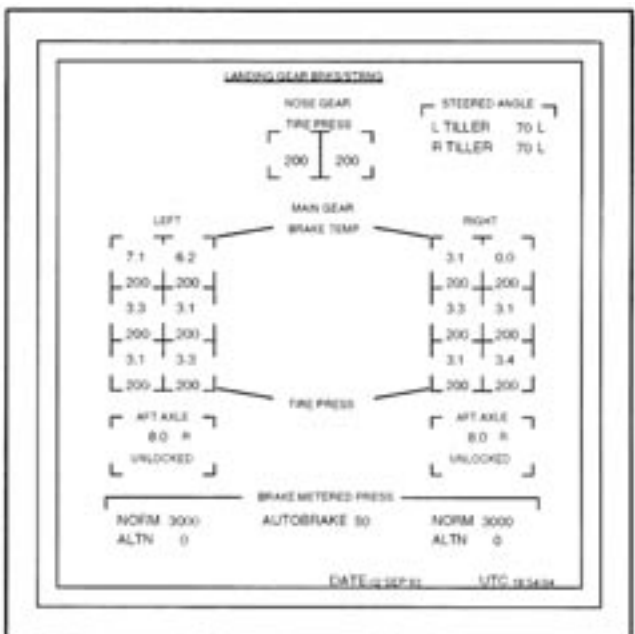
**Figure 3**

Brake and Steering Maintenance Page

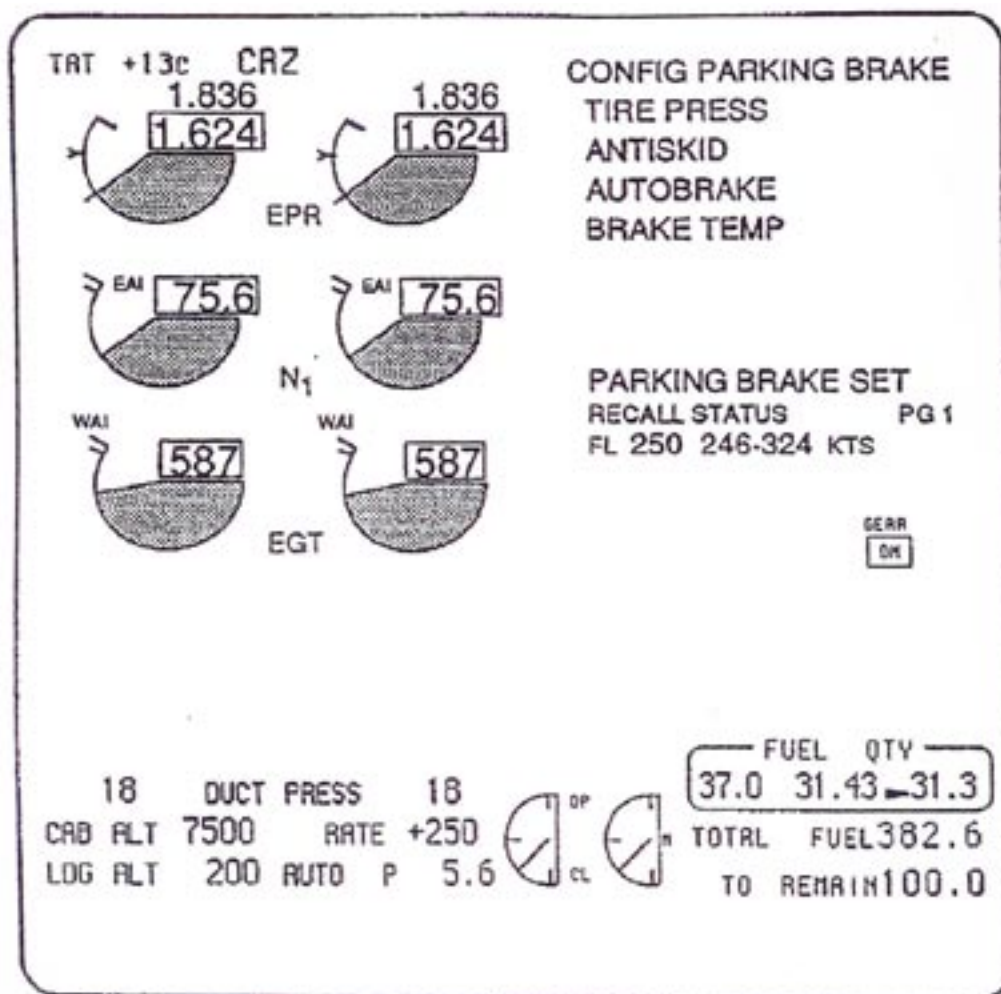
An advisory “BRAKE TEMP” message will appear in the Engine Indication and Crew Alerting System (EICAS) engine format page, Figure 3a (next page), when any brake temperature indication reaches or exceeds 5.0 and will stay on until all brake temperatures go below 3.5. Brake temperatures equal to or above 5.0 indicate that the thermal wheel fuse plug may melt. The hottest brake on each gear, if below 5.0 and equal to or above 3.0, will be indicated by a solid white brake symbol. If any brake temperature reaches or exceeds 5.0, then the value and the associated brake symbol will be amber. This amber symbol will extinguish if the brake temperature decreases below 3.5. A 0.0 indication is equivalent to a BTMS peak temperature of 38°C and 9.9 to 1038°C.

EICAS Main Format

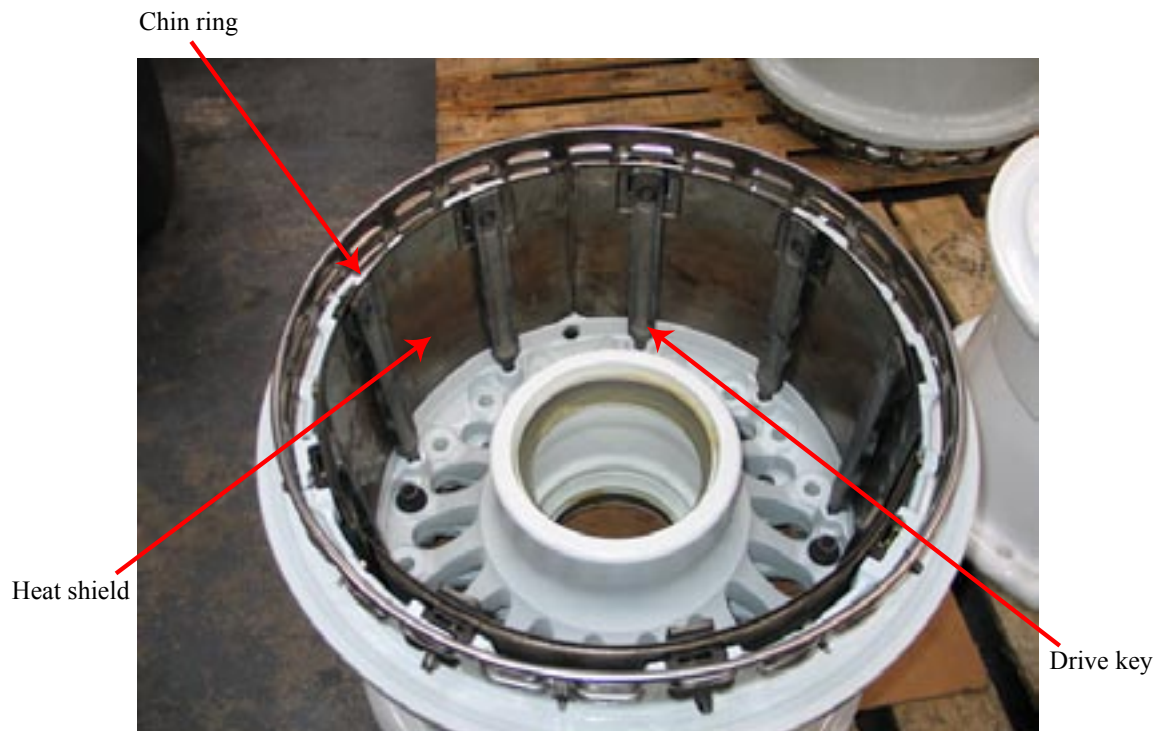
**Figure 4**  
Construction of main wheel

aluminium hub from the high temperatures generated by the carbon brake pack. The heat shields are constructed from two thin sheets of stainless steel, spot welded around their edges, and which contain an absorbent ceramic insulation material. They have a hole on the outer edge to allow the brake pack drive keys to be secured to the hub, and rubber bumpers fitted along the outside surface to prevent fretting against the wheel hub.
