Turbulence, Report on the accident to Airbus A330-342 B-HYA Within the Manila Flight Information Region on 18 July 2003

AIRCRAFT ACCIDENT REPORT 1/2005

**Report on the accident to
Airbus A330-342 B-HYA
Within the Manila Flight Information Region
on 18 July 2003**

**Hong Kong
May 2005**

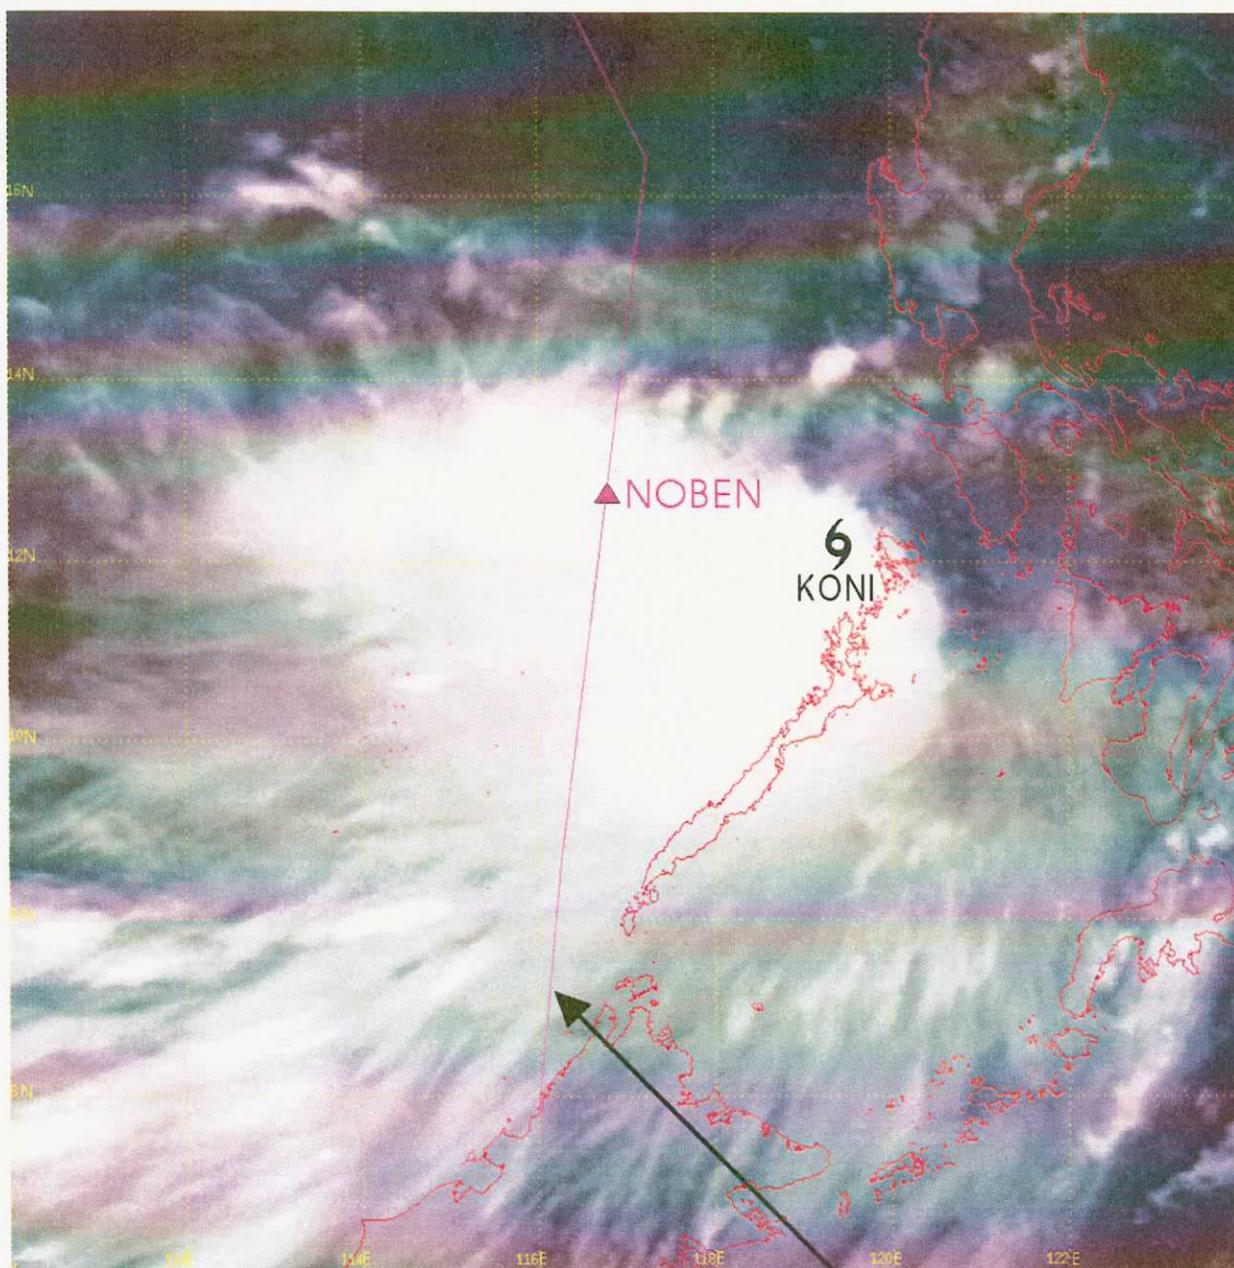
GOES-9 INFRA-RED SATELLITE PICTURE

0525 UTC 18 July 2003

Flight Plan Track of HDA060

The satellite imagery was captured with GOES-9 operated by the joint effort of Japan Meteorological Agency (JMA) and United States National Oceanic and Atmospheric Administration National Environmental Satellite Data and Information Service (US NOAA NEDIS). Position of “KONI” is a post-analysis position for 0600 UTC 18 July 2003.

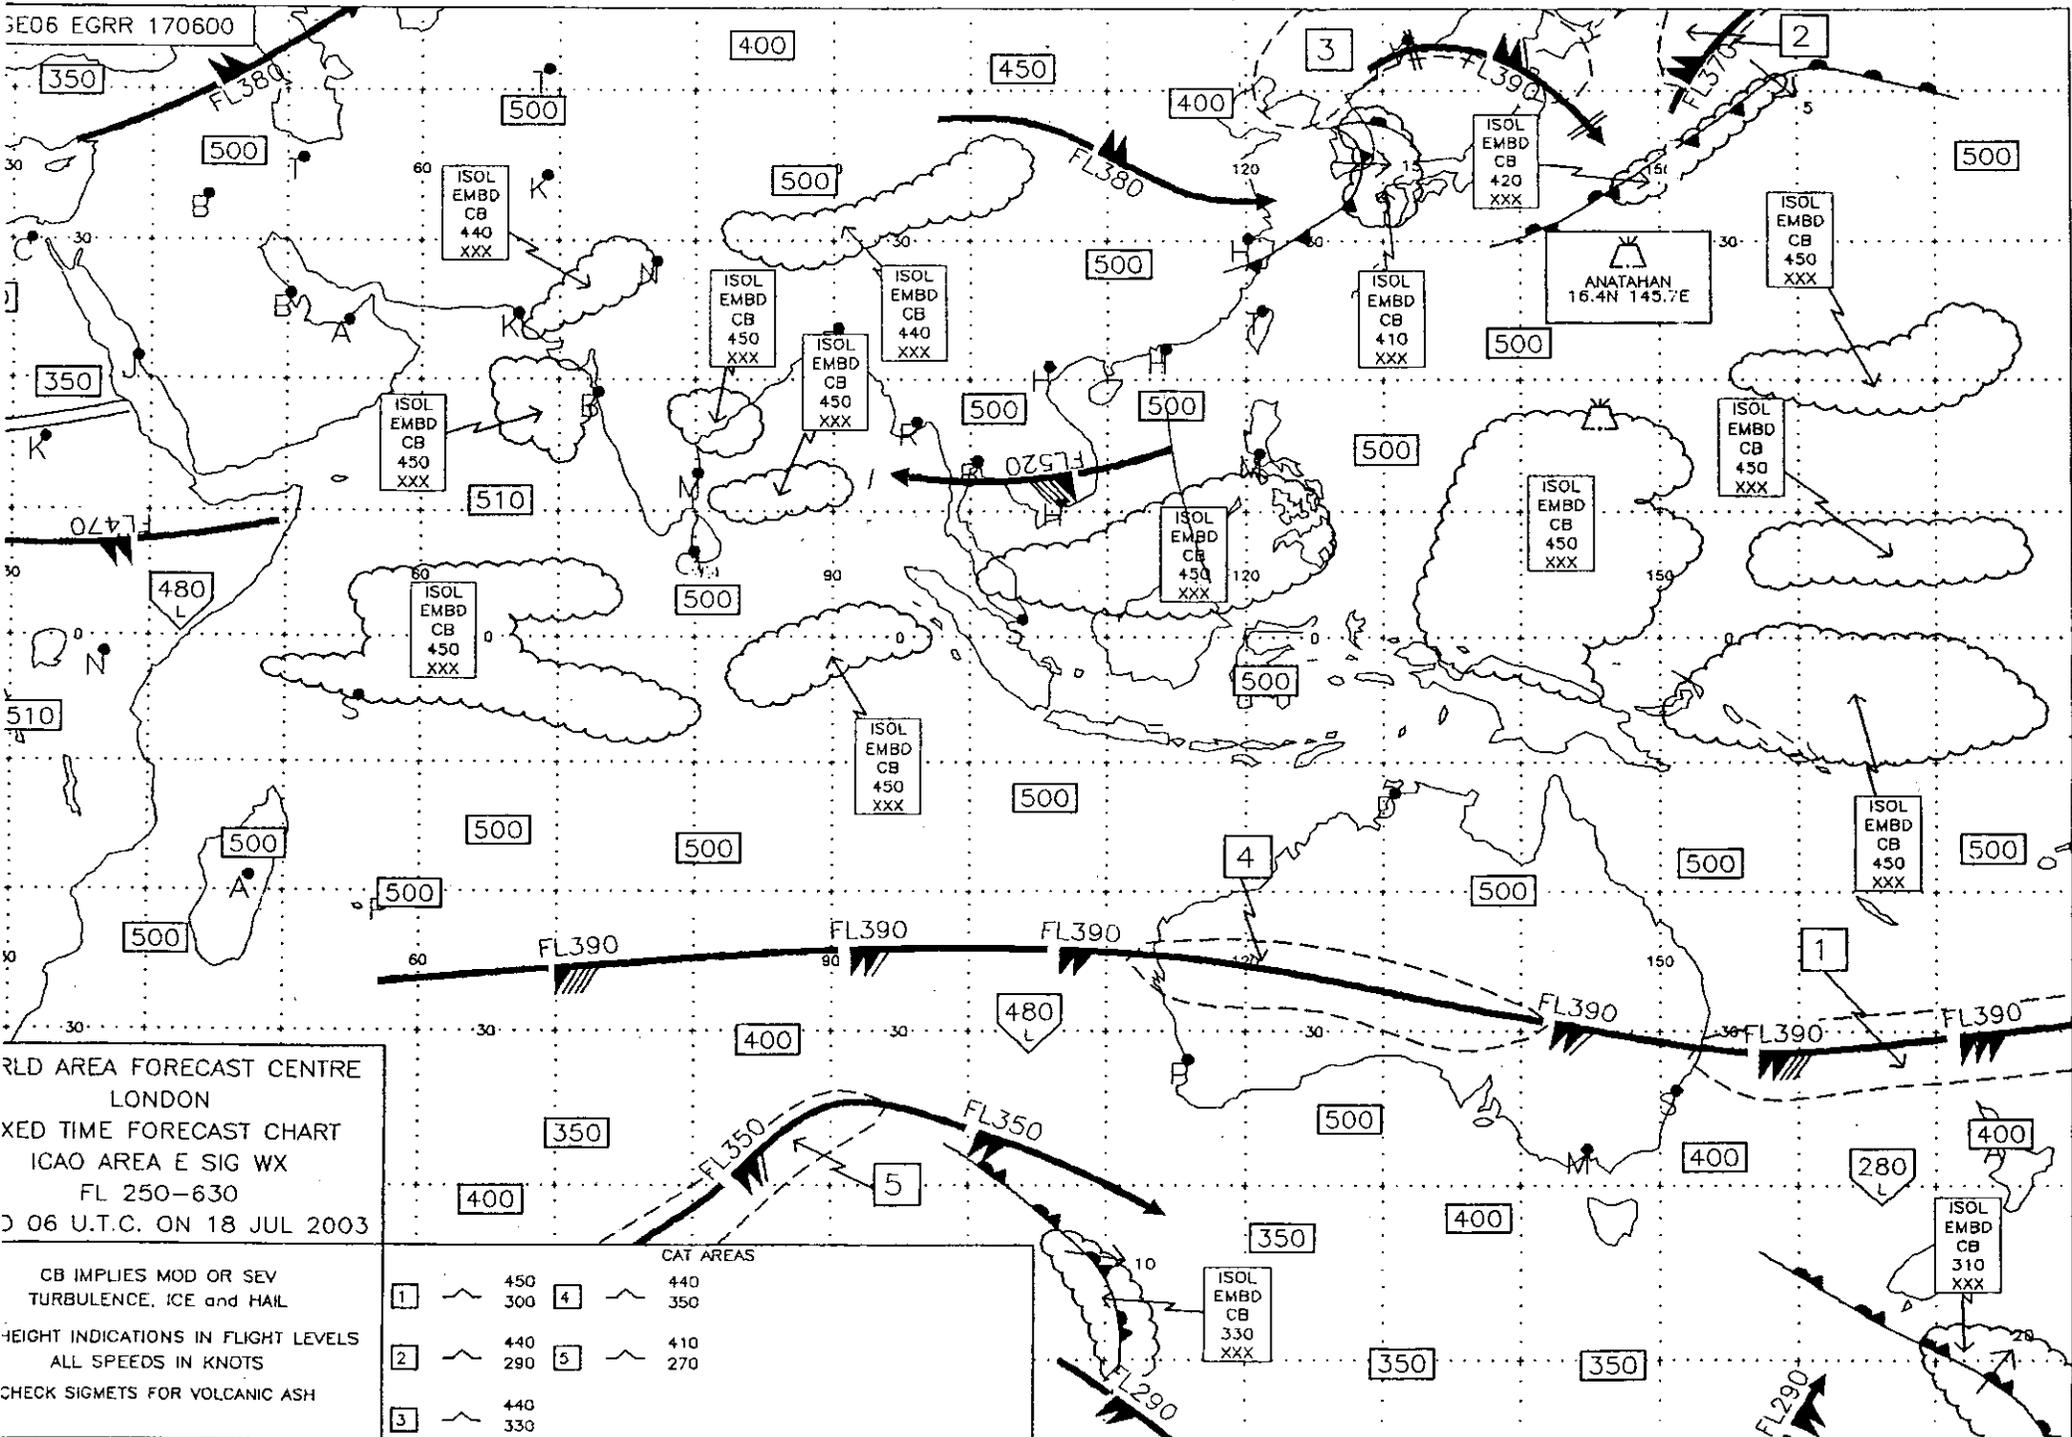
WORLD AREA FORECAST CENTRE
LONDON
FIXED TIME FORECAST CHART
ICAO AREA E SIG WX
FL 250-630
0600 U.T.C. ON 18 JUL 2003

CB IMPLIES MOD OR SEV
TURBULENCE, ICE and HAIL
HEIGHT INDICATIONS IN FLIGHT LEVELS
ALL SPEEDS IN KNOTS
CHECK SIGMETS FOR VOLCANIC ASH
