Descent from cruise and crash into river, Aircraft Accident Report, Silkair Flight MI 185, Boeing B737-300, 9V-TRF, Musi River, Palembang, Indonesia, 19 December 1997

Aircraft Accident Report

SILKAIR FLIGHT MI 185

FINAL REPORT

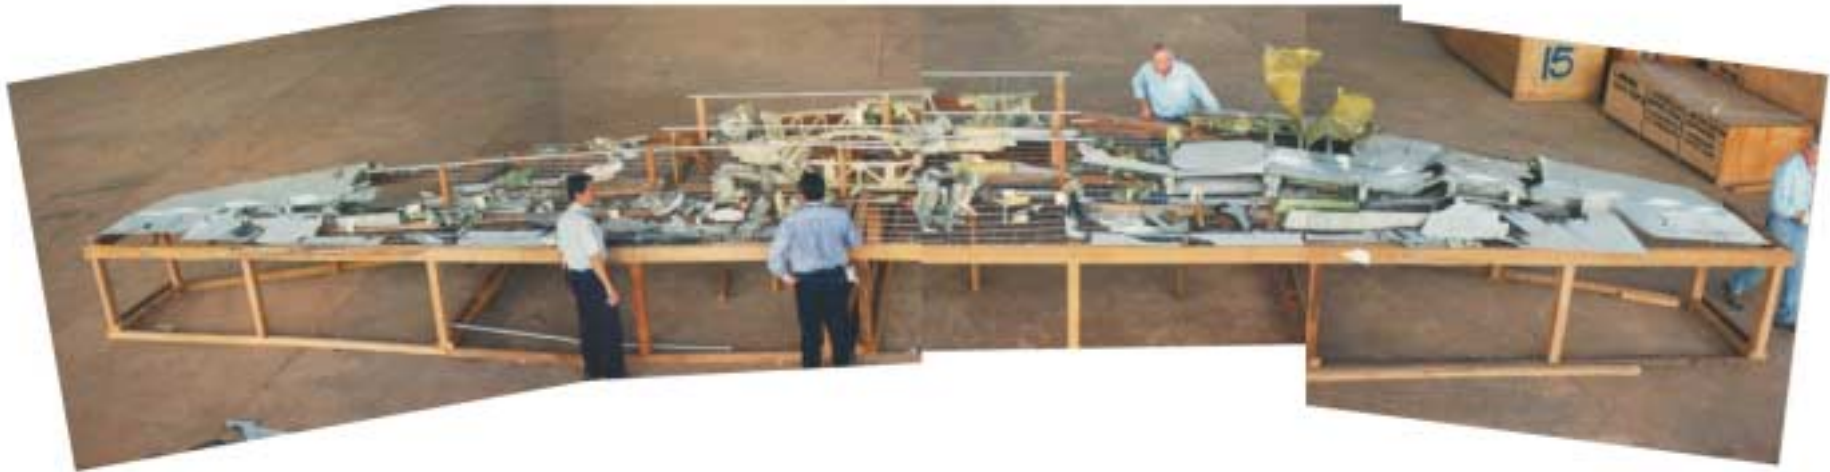
Figure 11 Picture of the reconstructed empennage

A wooden structure was constructed to mount parts of the horizontal stabilizer and elevators in their respective positions. The reconstruction facilitated documentation of the wreckage and the deformation of the pieces that had separated in-flight. The reconstruction work was done in a hangar in Curug near Jakarta, in March 1998. The reconstructed empennage is shown in Figure 11.

The parts of the horizontal stabilizer center section (“Texas Star”) were recovered in the river and were found broken due to impact, see Figure 11. In the recovered parts no evidence was found which could be attributed to fatigue failure.

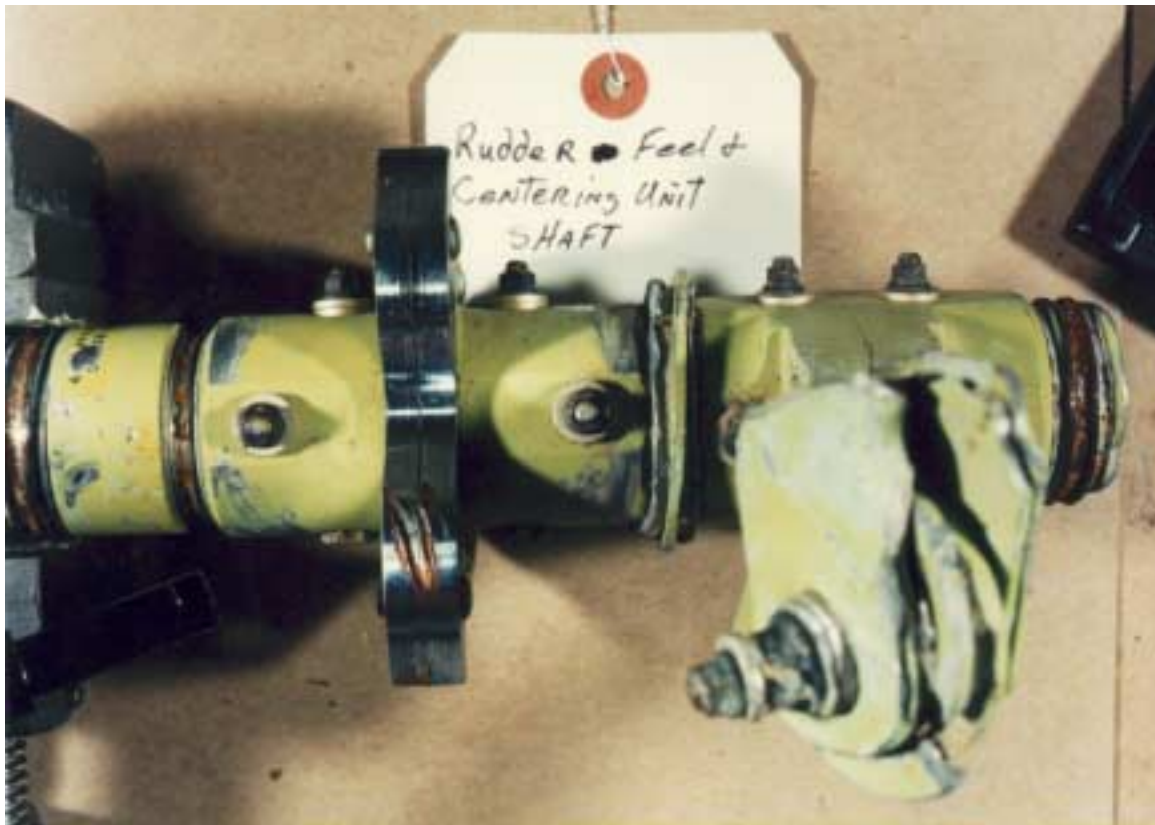
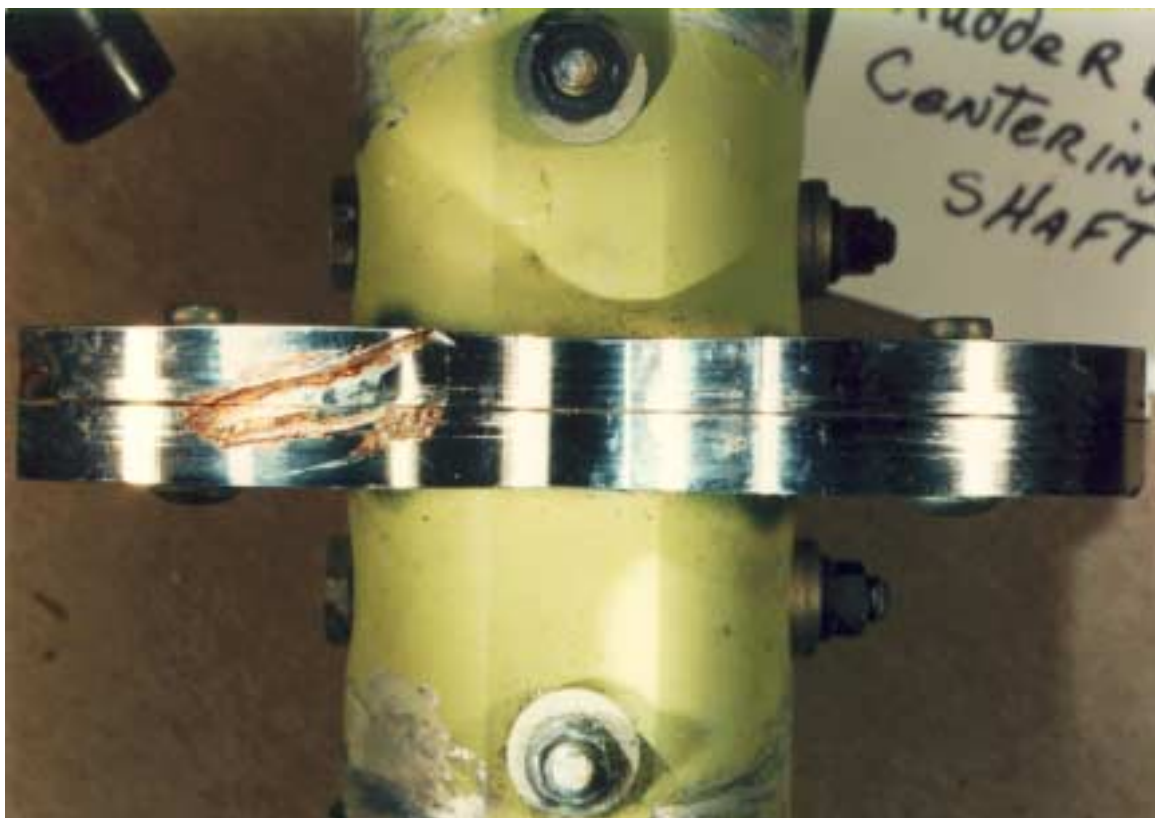
Figure 12 Picture of the impact marks at the cam feel centering unit

- d) The rudder trim actuator (Item 14 in Appendix E) was found to be close to neutral.
- e) The cam of the feel and centering unit (Item 22 in Appendix E) had impact marks indicating a left rudder deflection, (Figure 12).

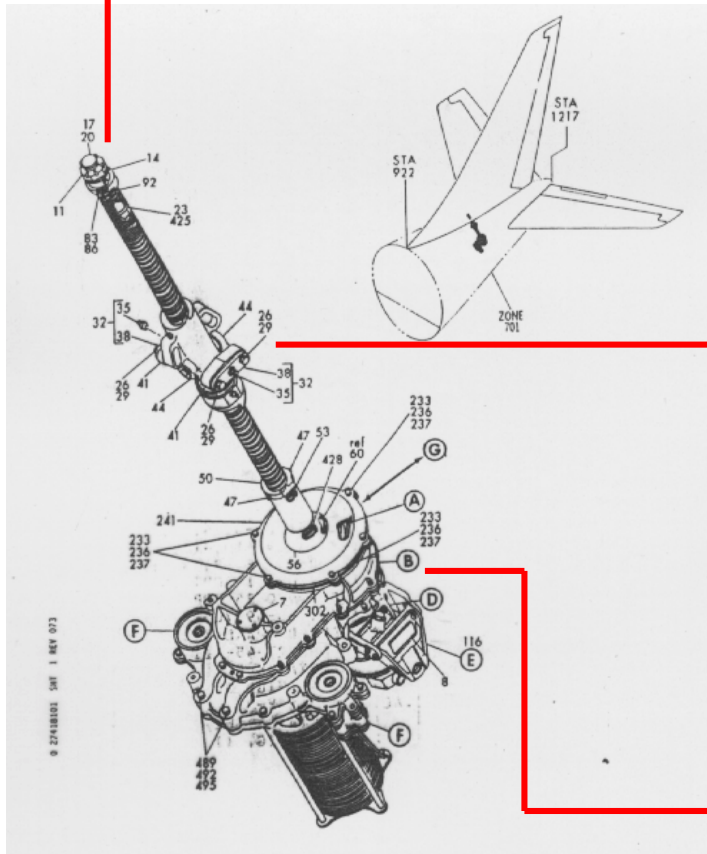
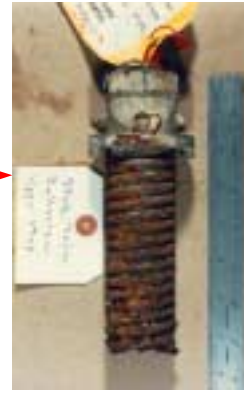
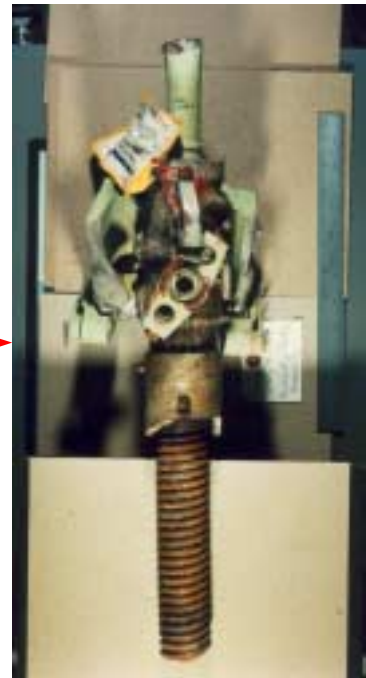
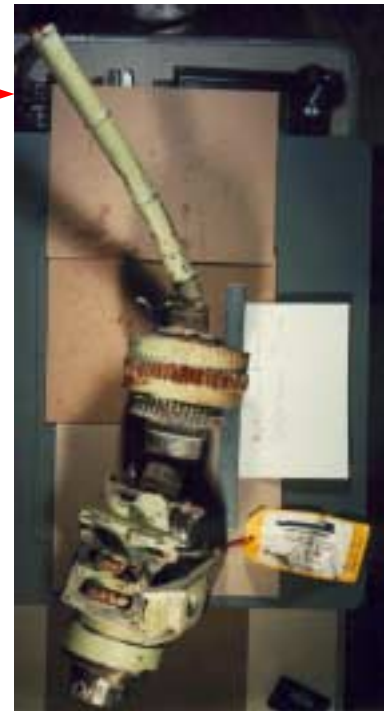
(c) Stabilizer Jackscrew

- i) Horizontal stabilizer jackscrew (Item 23 in Appendix E) – The pictures of the broken jackscrew are shown in Figure 13. The jackscrew ball-nut was found in a horizontal stabilizer trim position of 2.5 units, equivalent to 0.5 degree horizontal stabilizer

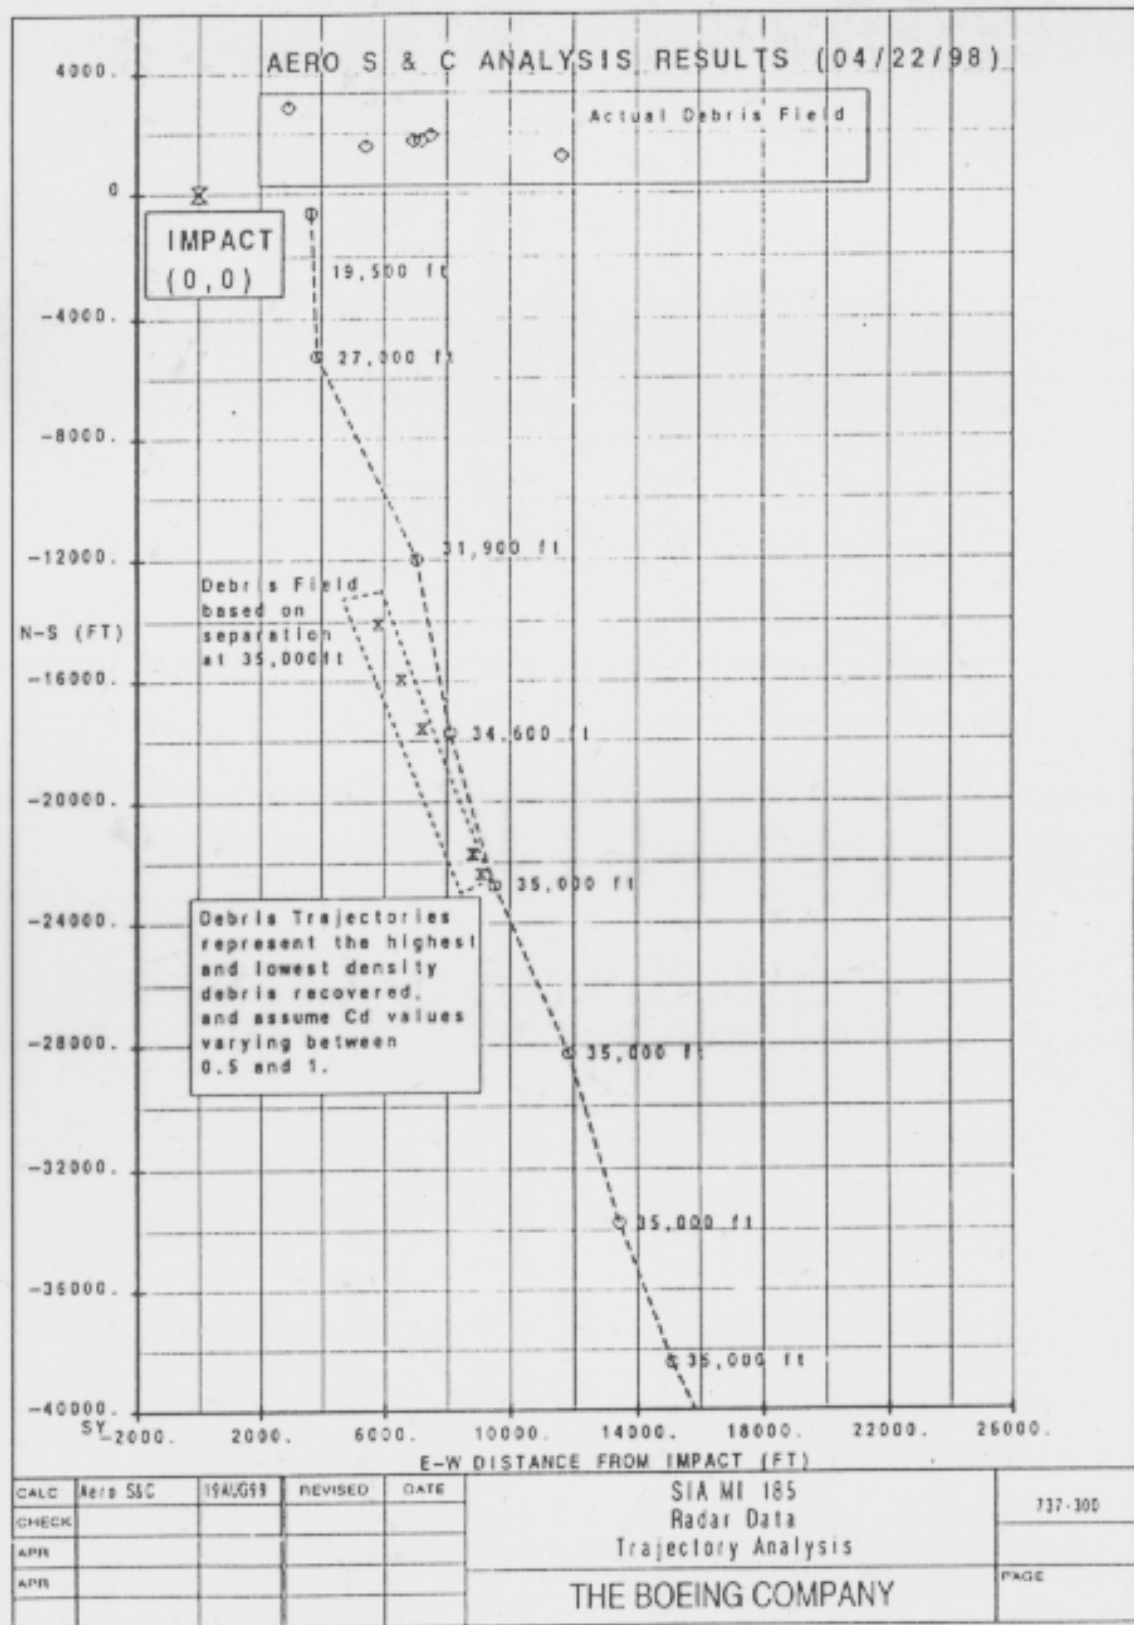
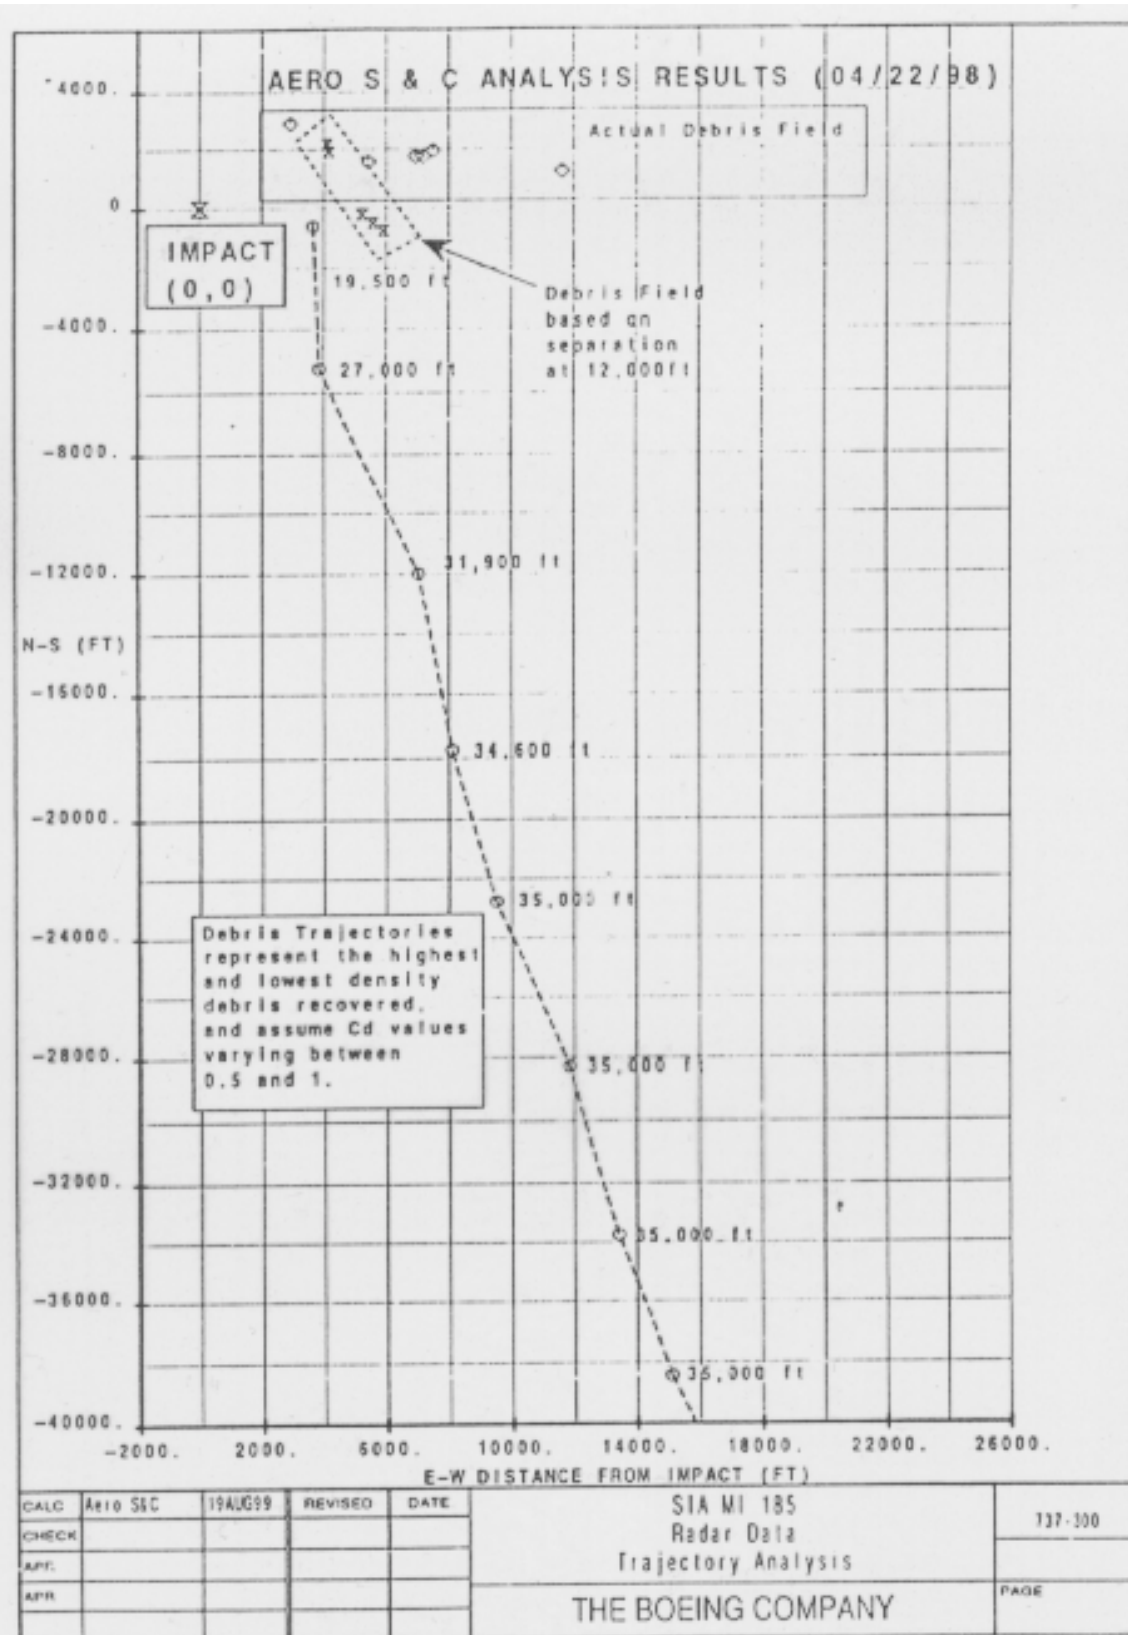
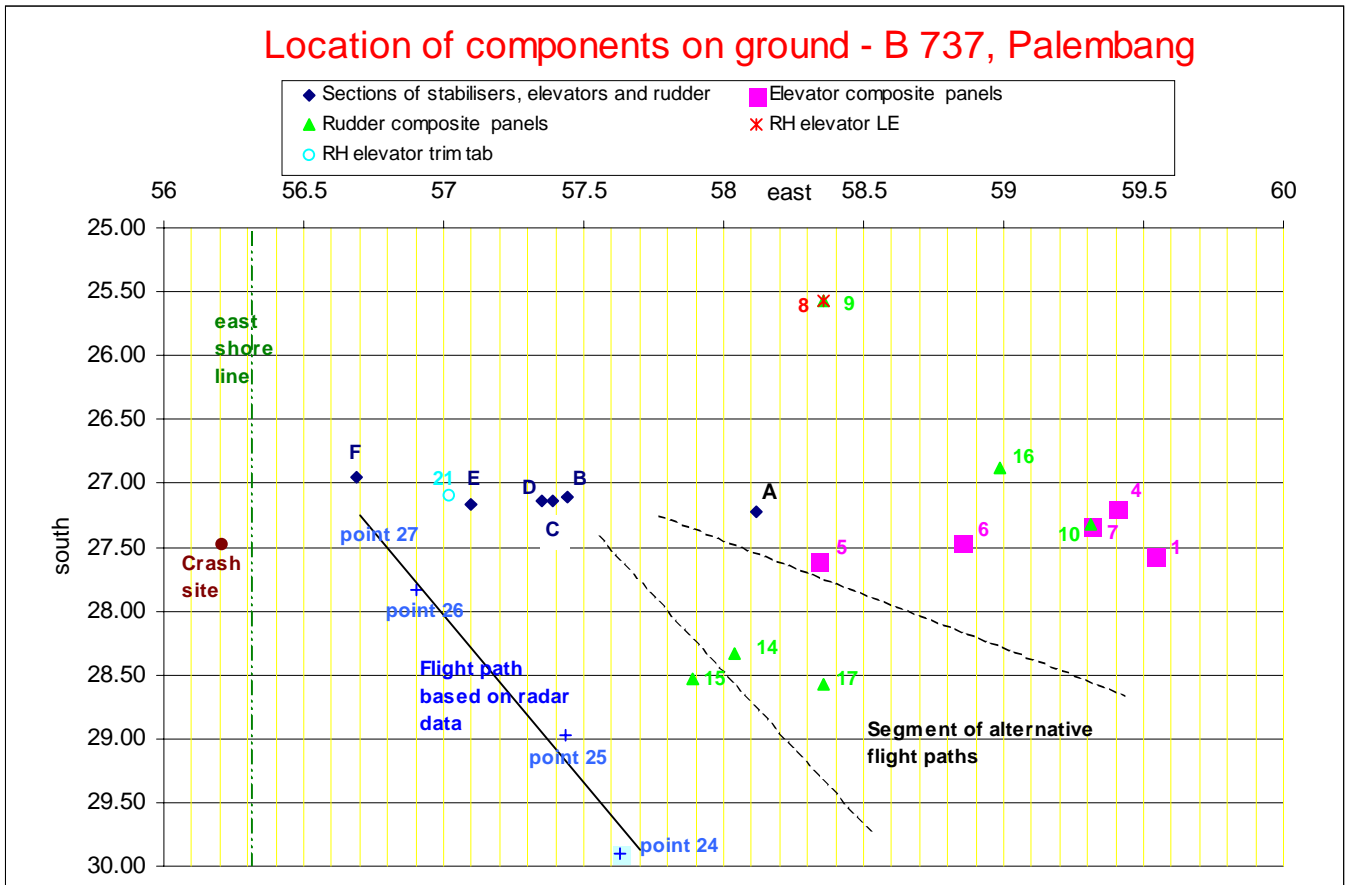
Figure 14 Diagram of debris distribution analysis

Both studies, see Figure 14, were based on the theory that the trajectory of a separated object was determined by its initial condition at the time of separation, such as mass, speed, heading, altitude and its aerodynamic characteristics as well as the wind direction.

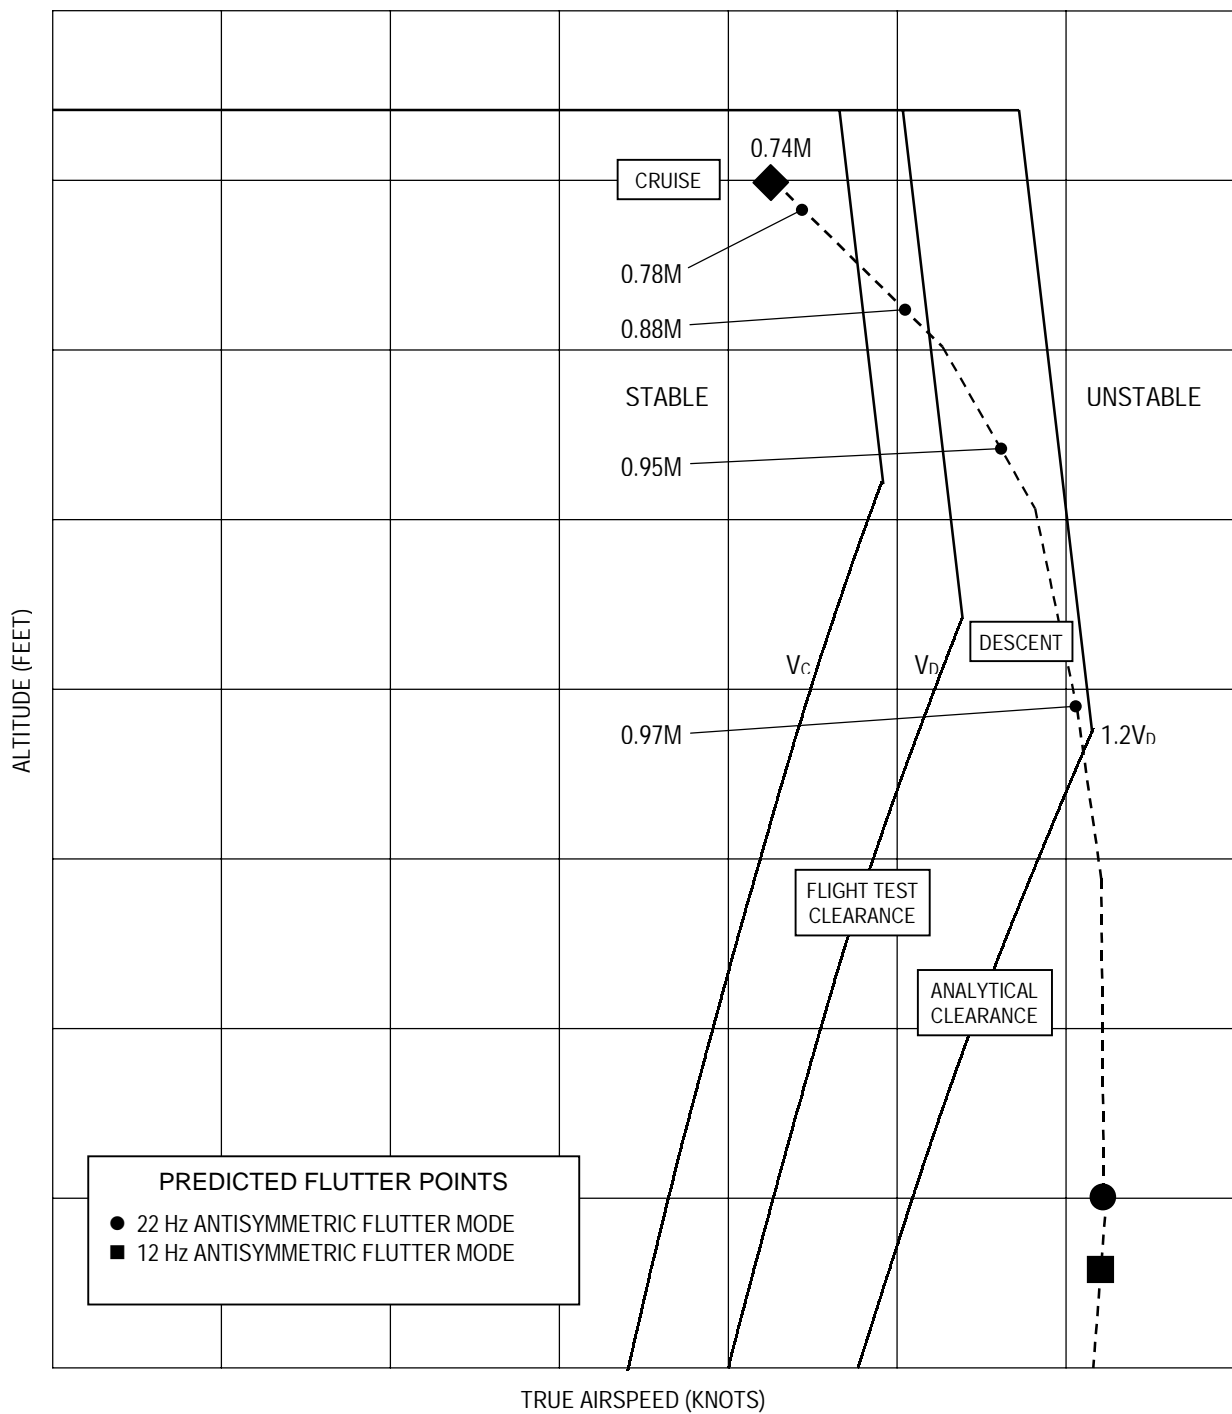
Figure 15 Diagram of Boeing B737 Flutter Flight Envelope

- During descent from 20,000 feet to ground impact
The applied static loads are less than the design ultimate load envelope and do not support separation of the empennage during the final descent below 20,000 feet. The estimated descent speed exceeded the 1.2 dive speed V_d analytical flutter clearance speed at approximately 18,000 feet altitude. An onset of an empennage 22 Hz anti-symmetrical flutter mode was calculated to occur later in the descent at approximately 5,000 feet altitude (570 equivalent airspeed in knots-KEAS). A lower frequency 12 Hz anti-symmetrical flutter mode was calculated to occur at approximately 3,000 feet altitude (600 KEAS), see Figure 15.

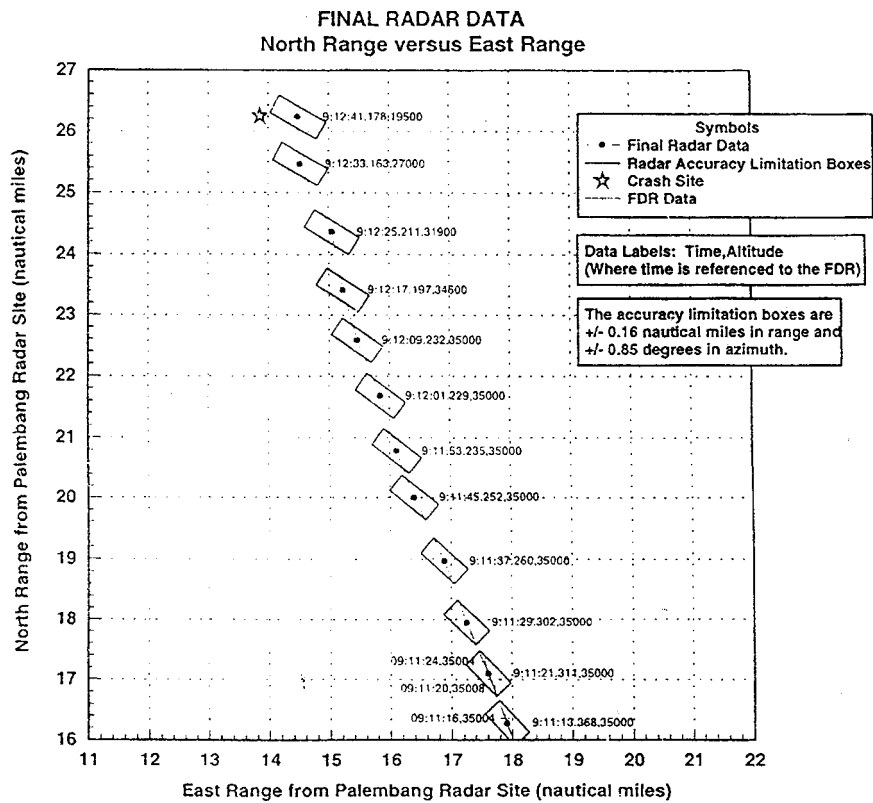
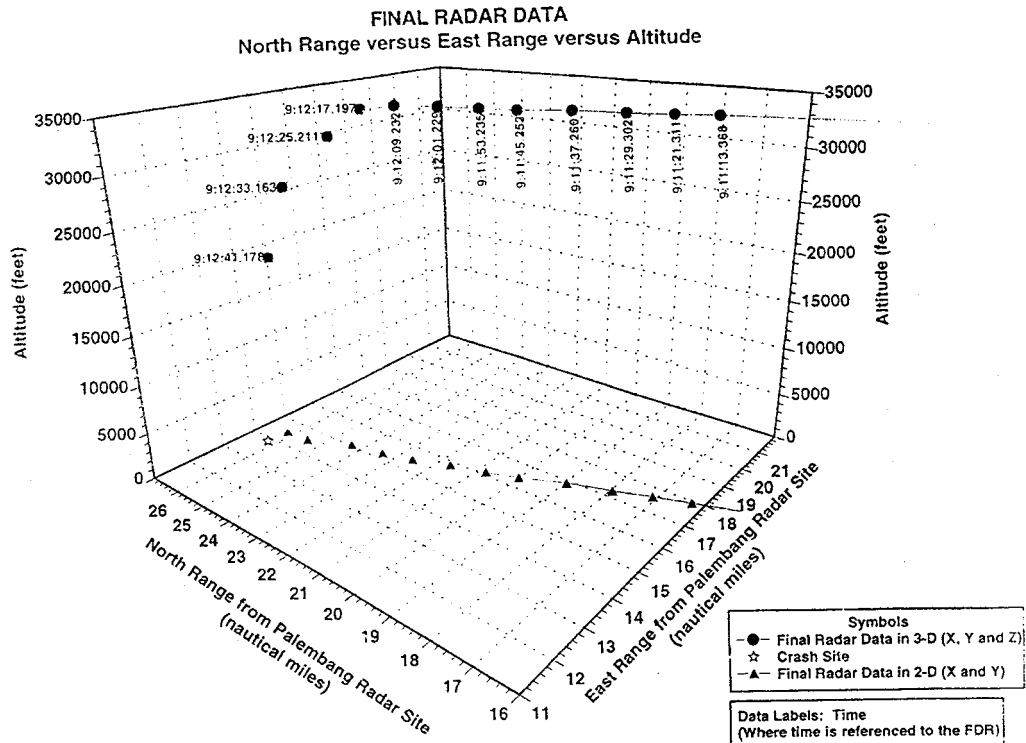
Figure 16 Corrected Radar Data

The radar data and information retrieved from the GUARDIAN system was further examined and corrected, by Boeing as well as NTSB, focusing particularly on the last twelve radar returns. Based on this final radar data, the aircraft flight path and its ground track projection was reconstructed, see [Reference 18] and Figure 16.
