Precautionary diversion on an Airbus A330-301 (EI-JFK) following takeoff from Dublin, Ireland, June 4, 2004.

FINAL REPORT

1 **AAIU Synoptic Report No: 2006-006**

Aircraft Type and Registration:	Airbus A330-301, EI-JFK
No. and Type of Engines:	2 x GE CF6-80E1A2
Aircraft Serial Number:	086
Year of Manufacture:	1994
Date and Time (UTC):	4 June 2004 @ 10.07 hrs
Location:	On take off from RWY 28, Dublin Airport
Type of Flight:	Scheduled Public Transport
Persons on Board:	Crew - 12 Passengers - 303
Injuries:	Crew - Nil Passengers - Nil
Nature of Damage:	No damage to aircraft
Commander's Licence:	ATPL
Commander's Details:	Male, aged 44 years
Commander's Flying Experience:	15,000 hours of which 110 were on type
Information Source:	Operator informed AAIU

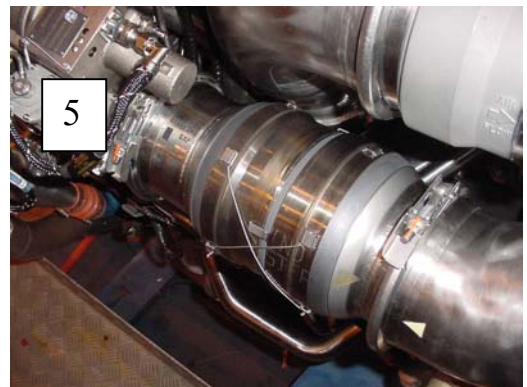
The tension loading introduced into the 14th stage manifold lower coupling installation by the unrestrained TTU inner duct, exacerbated by a HPV cyclic loading component due to the loss of TTU support, initiated a fatigue fracture in the coupling. Fracture propagation continued to the point of coupling failure.

Photo 1: The 14th Stage Manifold on a tool rig
Photo 2: The failed manifold coupling position
Photo 3: The fractured clamp
