AVIATION OCCURRENCE REPORT

02-010

Boeing 747-419 ZK-NBS flight NZ 2, in flight flap separation
over Manukau Harbour by Auckland International Airport

30 August 2002

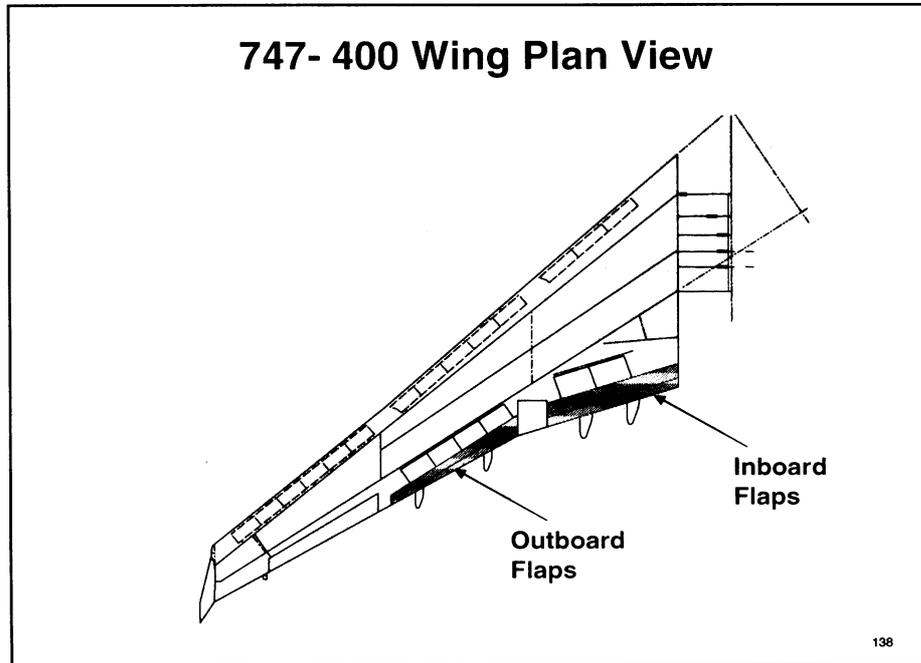
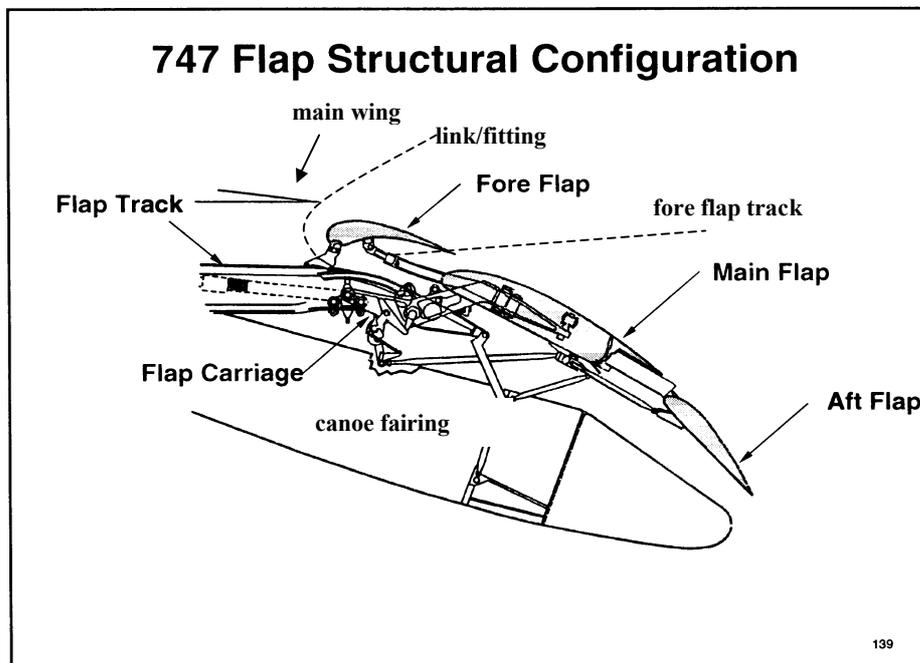
Figure 2
Boeing 747-400 trailing edge flaps

- 1.4.11 The trailing edge main flap was attached to, and supported by, 2 flap tracks in the wing by carriages (the moveable attachments between the flap and flap track), which were driven by a ball screw. The fore and aft flaps were attached to and moved with the main flap. The 3 segments were mechanically separate and formed 3 slots as the flaps extended. The flap tracks programmed the change in flap angles as the flap extended. Three fore flap (or mid flap) tracks in the main flap attached to and supported the fore flap. The front of the fore flap was attached to its respective roller carriage assembly by an inner link and an outer fitting (see Figures 2, 3 & 5).

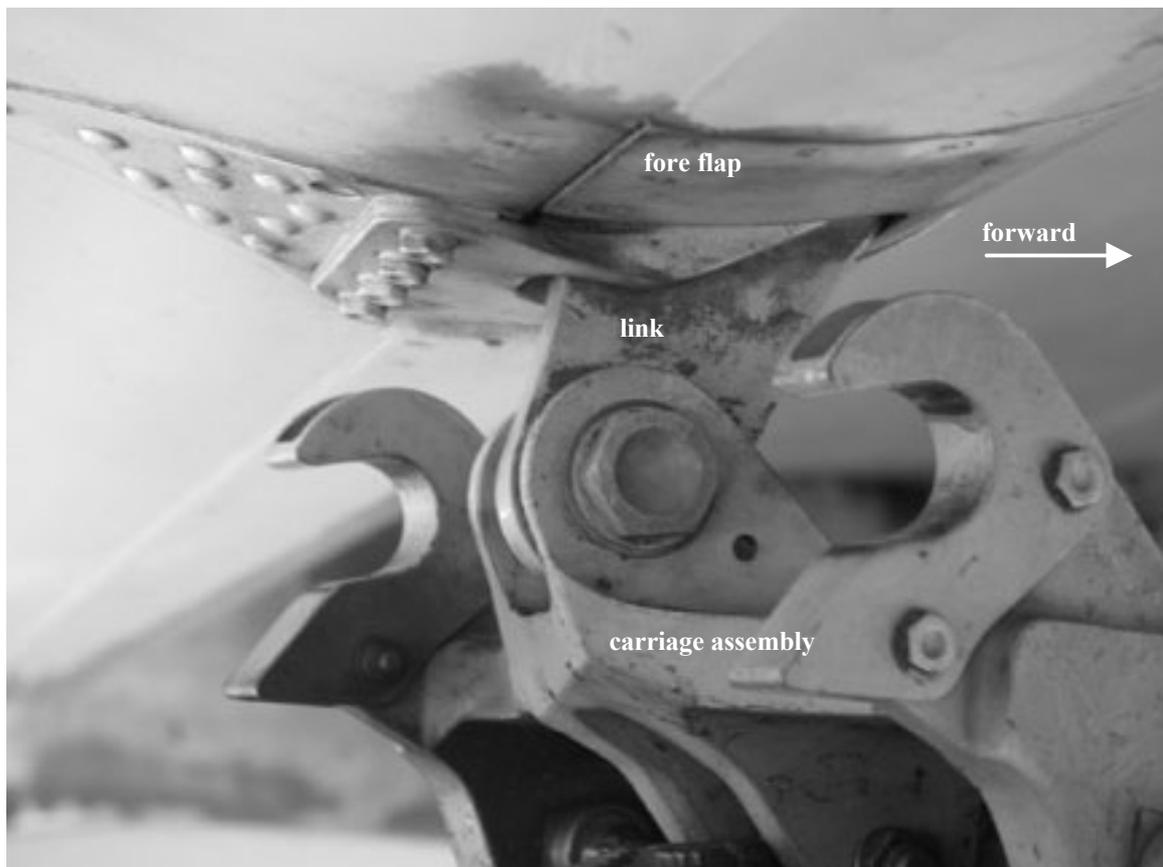
Figure 3
Fore flap and link on another aircraft

- 1.4.12 The fore flap inner link contained a swaged self-aligning monoball phenolic bearing, with Teflon lining that provided the lubrication for the inner spherical monoball. The bearing was made from stainless steel material and was press-fitted into its housing in the aluminium alloy

link. The bearing edge was peened⁵ to prevent it moving in the housing. The bearing was bolted to a clevis⁶ on the fore flap carriage assembly. There was no provision to lubricate the phenolic fore flap link bearing, whereas there was provision to grease the fore flap outer fitting bearing.
