Dual electrical failure, Incident involving aircraft SE-LGZ in the air space over Mariehamn, Sweden on 31 January 2003

Report RL 2004:26e

Incident involving aircraft SE-LGZ in the air space over Mariehamn, Sweden on 31 January 2003

Case L-03/03

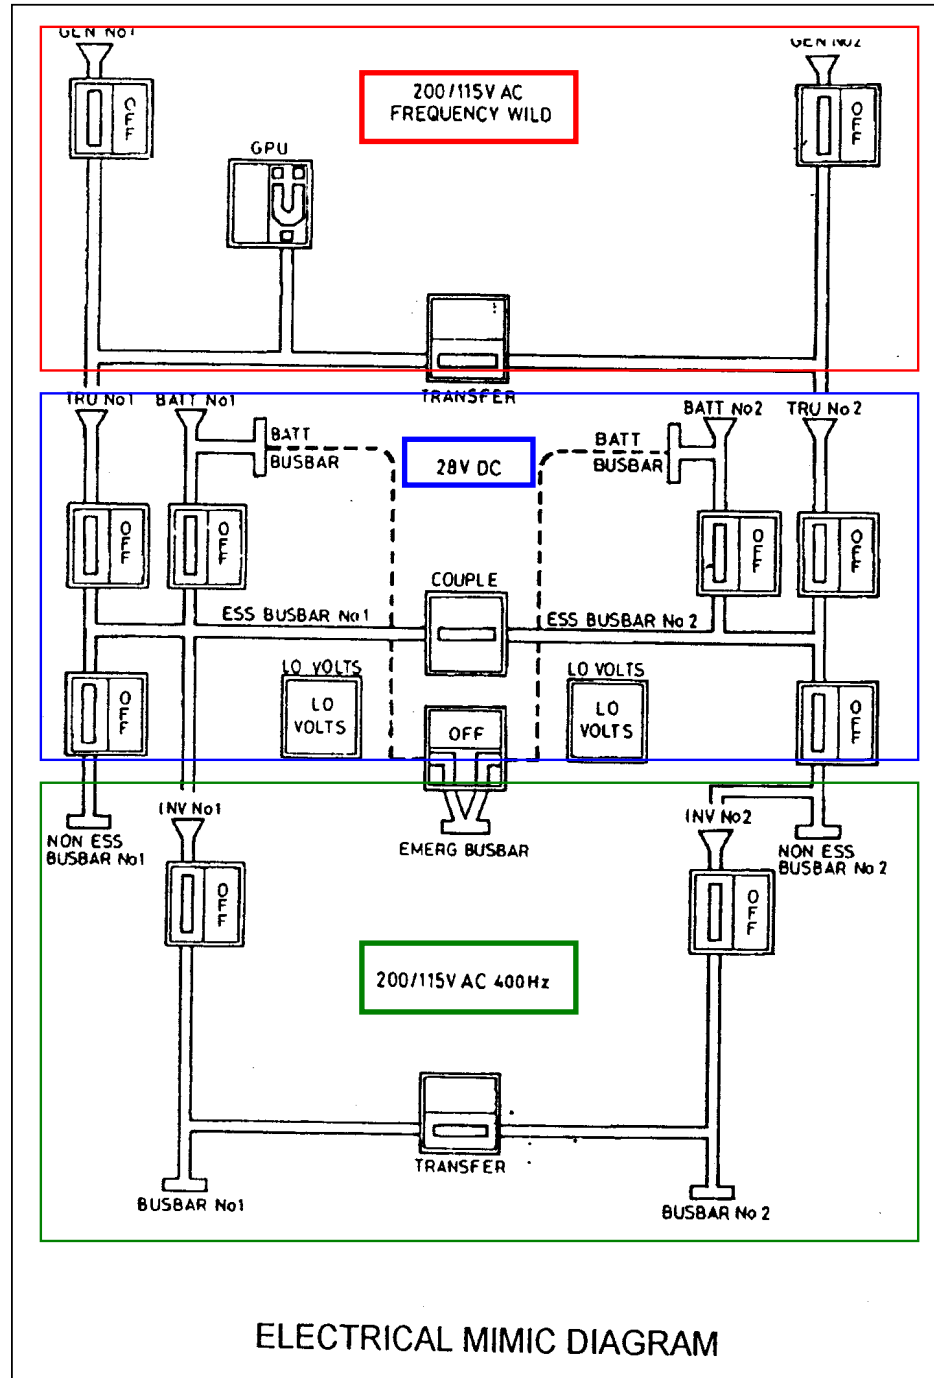
Electrical systems

From the 28V DC-system the voltage is transformed to 115V AC via two inverters. The load from one inverter system can be transferred from one system to the other by first deselecting the relevant inverter and then select the other one via the TRANSFER-button.

The systems are electrically connected and influence each other through different types of checking, regulating and warning system.
