Runway Overrun During Landing On Taipei Sungshan Airport, Transasia Airways Flight 536, A320-232, B-22310, October 18, 2004

GE 536 Occurrence Investigation Report

Runway Overrun During Landing On Taipei Sungshan Airport

A320-232, B-22310

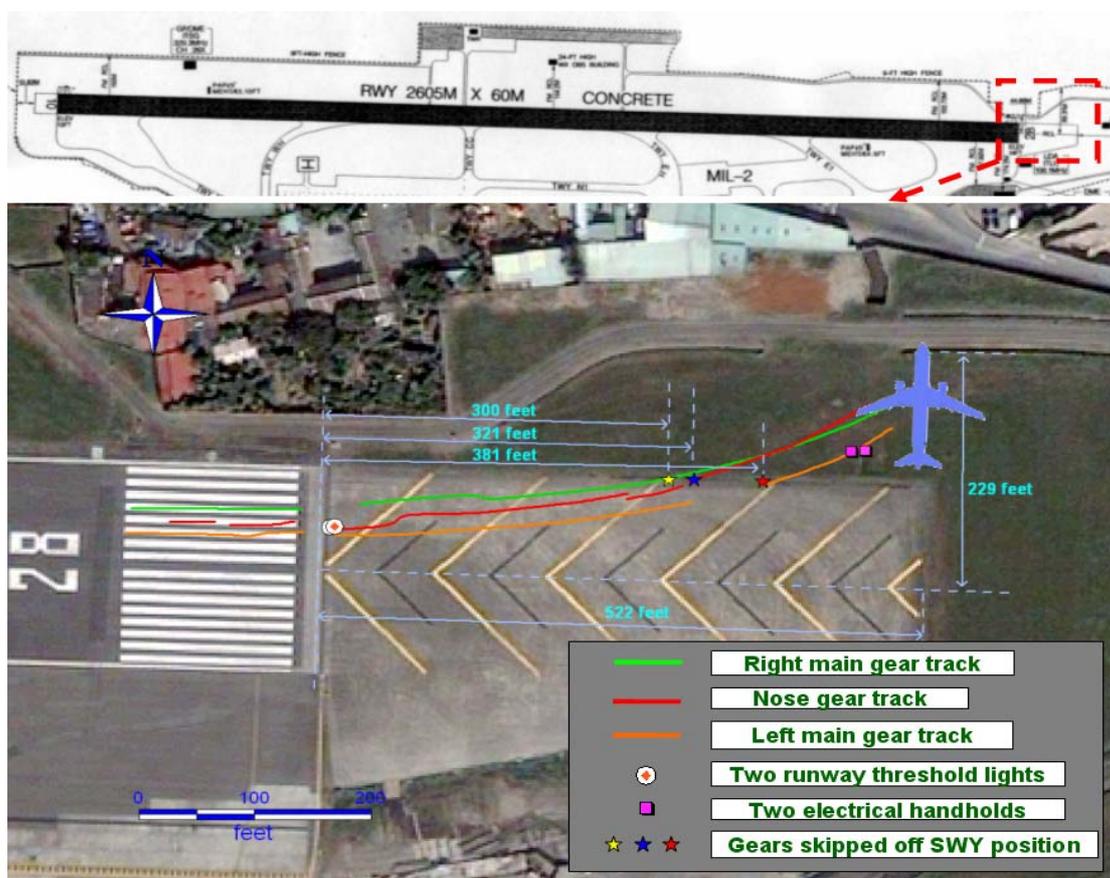
Figure 1.18-1 Sunghshan airport chart and site-survey results with the satellite image

According to the site-survey result, the nose gear of the occurrence aircraft skipped off the pavement of the stopway at 321 feet outward the threshold of Runway 28. The nose gear stopped in the uncovered ditch at about 130 feet in the north of the stopway (Figure 1.18-2). The aircraft stopped with heading 002 and nose downward slightly.

The tire marks of the aircraft could be tracked from the grass area, via the pavement of the stopway, continuously to the runway threshold markings of Runway 28 (Figure 1.18-3). No apparent tire marks of the occurrence aircraft could be found on the runway.

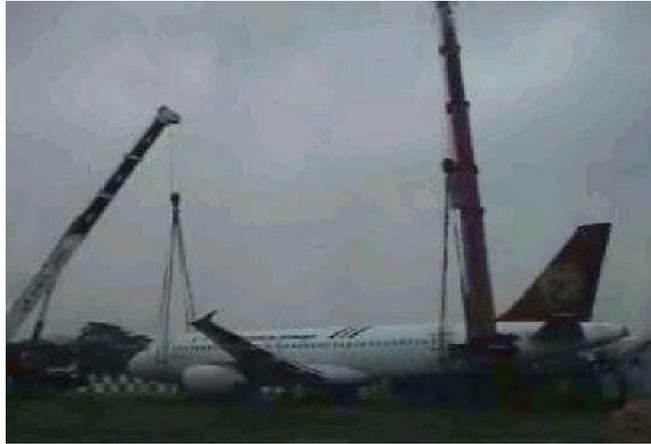
Figure 1.18-4 Aircraft with slings at Frame 15, 21 and 62

Recovery of the aircraft was performed by TNA. An airbag was placed at the RH wing root but did not have sufficient height to enable recovery. The lifting of

the fuselage was carried out with slings at Frame 15, 21 and 62 (Figure 1.18-4) . With the damaged NLG resting on a trolley and slings around the two main landing gear the aircraft was pulled directly backwards with a vehicle to a solid surface (Figure 1.18-5) .

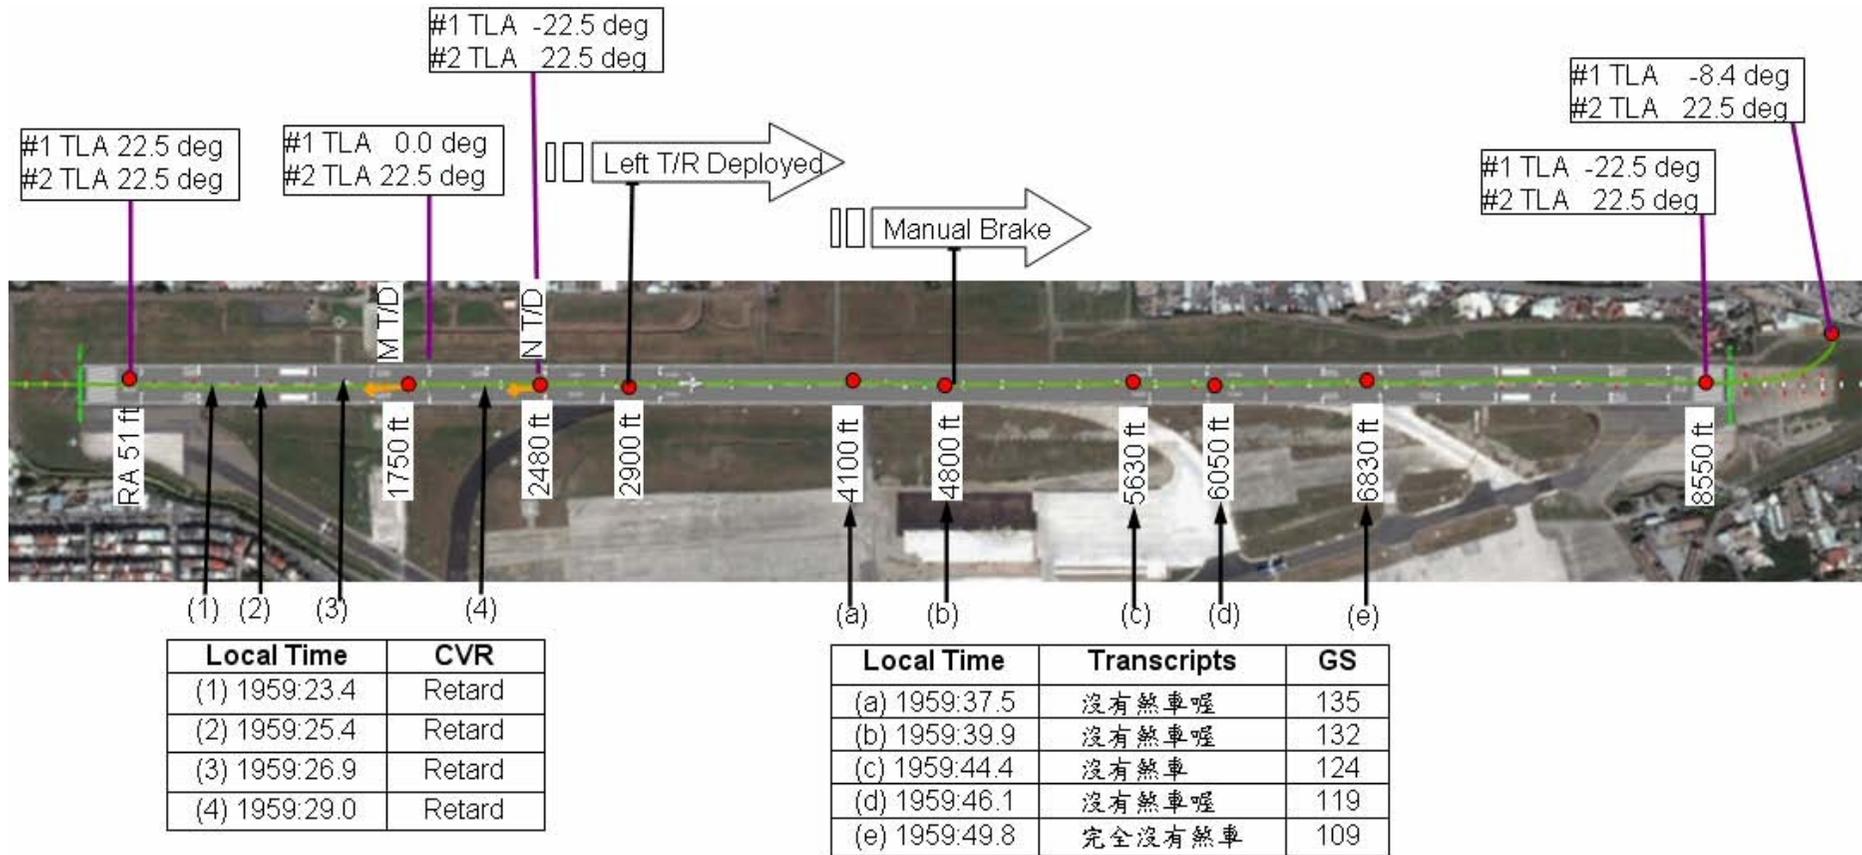
Figure 2.3-1 The relative locations determined by the CVR and FDR recorded data during landing phase.

After converting the CVR audio data²¹ into spectrogram, it is compared with FDR records. See Fig. 2.3-1 for the result of comparison.

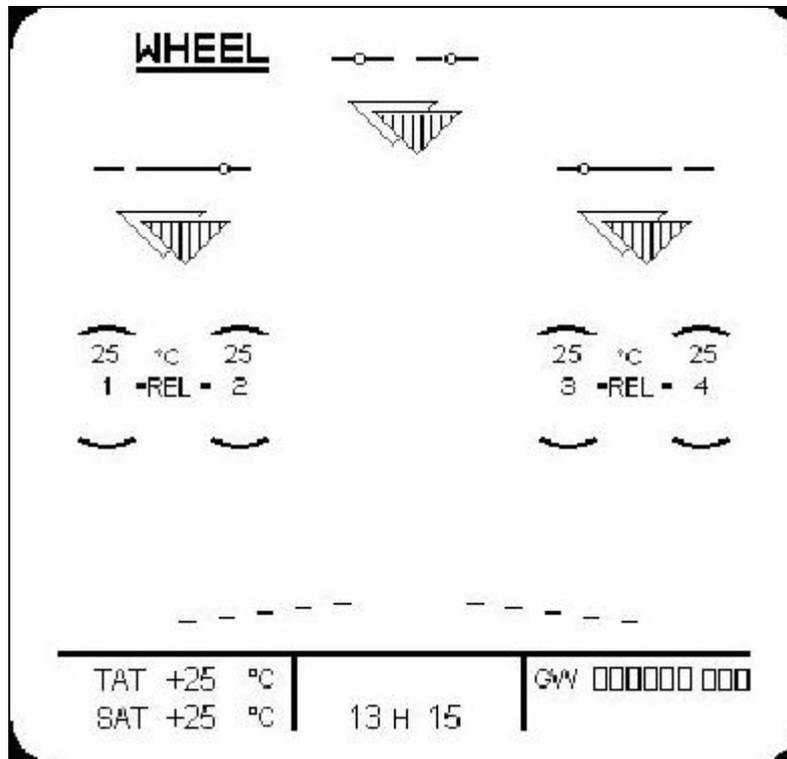
Figure 2.3-4 An ECAM display shows the ground spoilers are not extended

At 1959:27hr, the LH/RH landing gears touched down simultaneously. At 1959:29 hr, CM-1 declared “spoiler one reverse green and”. According to the analysis of Sec.2.3.3.2, as the ground spoilers were not activated and extended, the indications on ECAM screen should be “-”, as figure 2.3-4 shows. While his flight hours have exceeded 8700 hours, CM-1 is supposed to be quite familiar with the touchdown announcing practice. The ECAM page has shown that the ground spoilers were not extended, but “spoiler” was announced automatically, without any effective ECAM check. This could be translated into that the pilot did not check ECAM indications according to the requirements of SOP before announcing. Also, due to raining, tail wind, and at that time only the reverser in one side of the aircraft could be activated which tended to cause excursion, the pilots’ attention was focused on the rolling direction and deceleration, thus the retraction of ground spoilers was ignored.

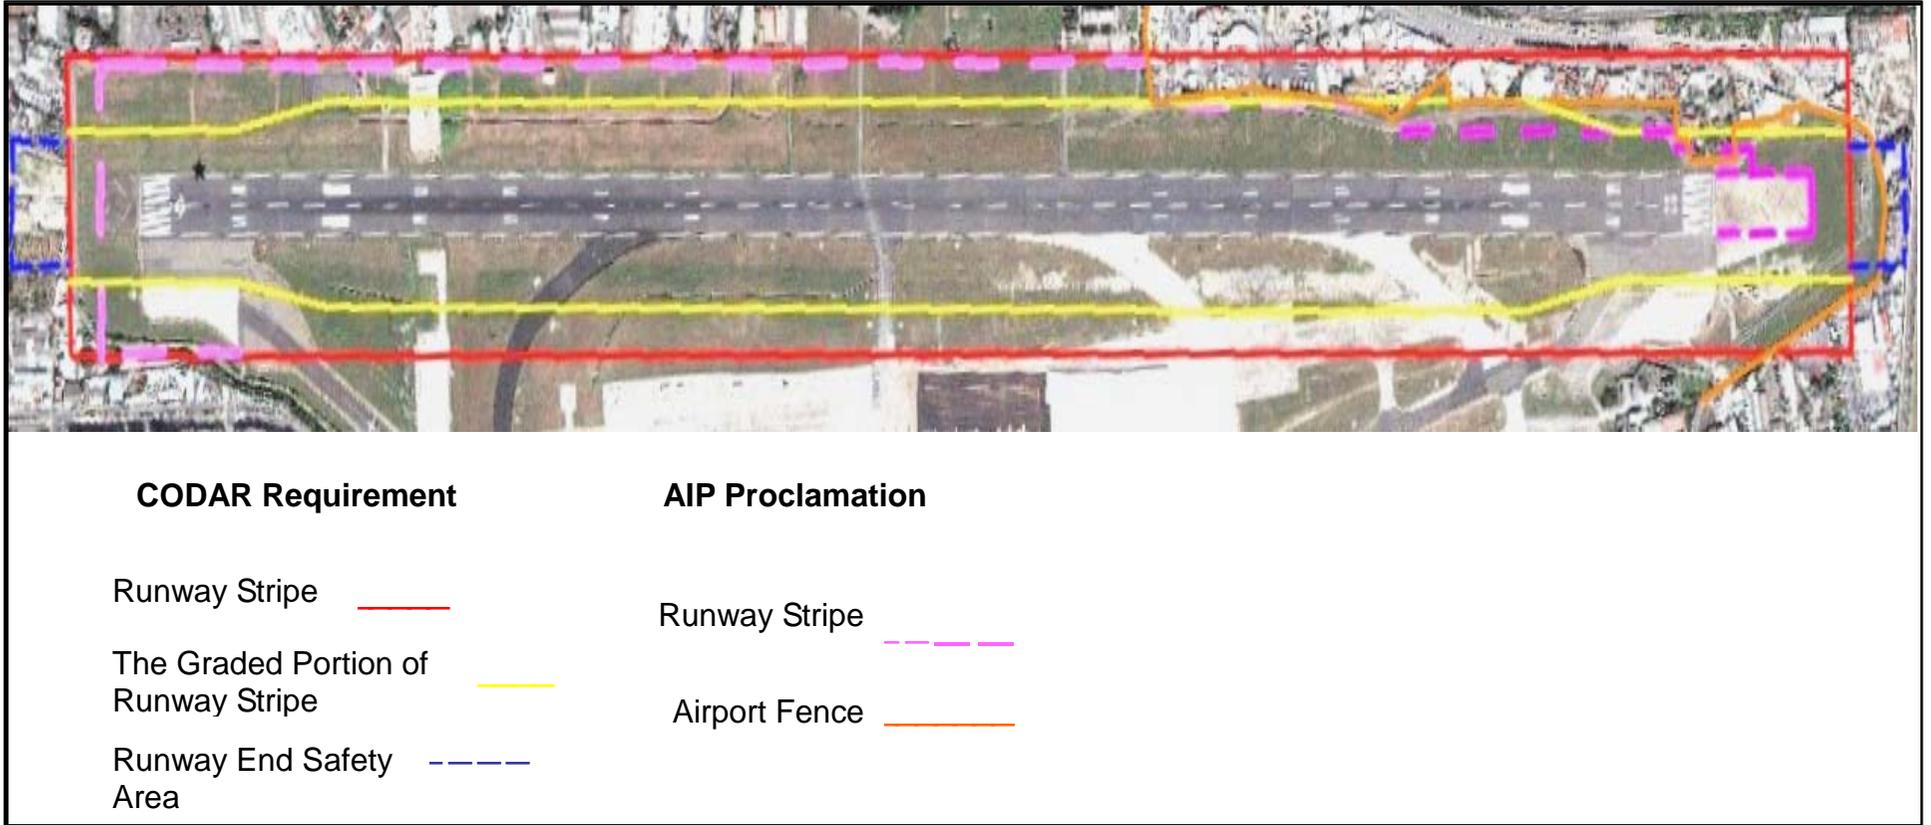
Figure 2.6-2 A comparison between official Runway Safety Area requirements and AIP Proclamation

The width of the runway end safety area shall be at least 120m³³, see Figure 2.6-2. However, there is a fixed fence about 15 meters to the north of the sideline of Runway 28 threshold. In case of an aircraft excursion, the fence and the civilian houses outside the fence could be stricken. In addition, there is an east-west uncovered drainage ditch extended irregularly at the site 43 to 69 meters to the north of central line of runway and its stopway. The ditches do not meet the requirements which call for flatness within the graded portion within the runway stripe.

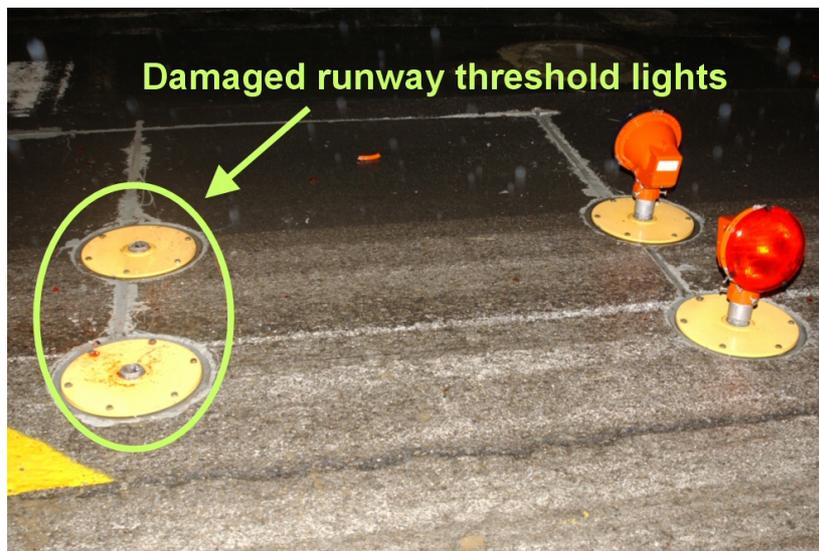
Figure 1.4-1 Damaged runway threshold lights

From the observation of the tire marks, the nose gear passed through two runway threshold lights (Figure 1.4-1) . The right main landing gear passed through two electrical handholds. Wreckages of the damaged electrical handholds were shown in Figure 1.4-2.

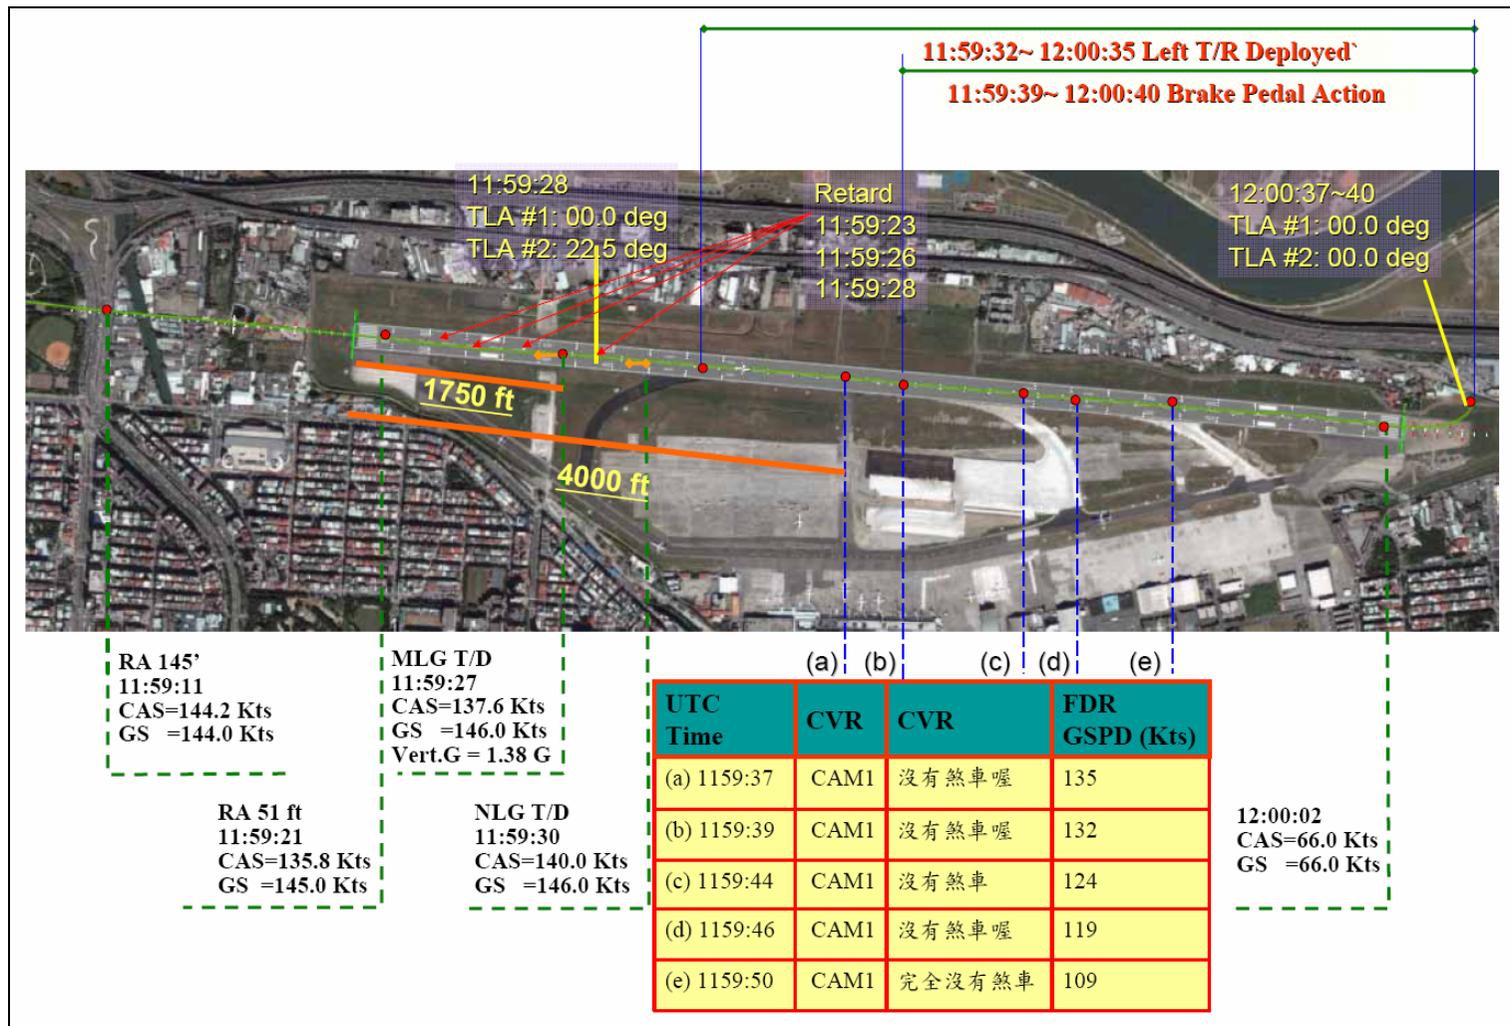
Figure 1.11-3 Superpose of Flight Path and Satellite Image (Time, Flight Path, FDR Parameters, and CVR Transcripts)

The touched ground position and timing is determined by parameters of "Landing Gear RH/LH Compressed Shock Absorber" and maximum vertical acceleration, as shown in Figure 1.11-3. At 1959:27, main landing gear touched ground at 1,750 feet beyond the threshold of runway 10. At 1959:37, Captain called out "No brake", the GE536 located at 4,000 ft beyond the threshold of Runway 10.

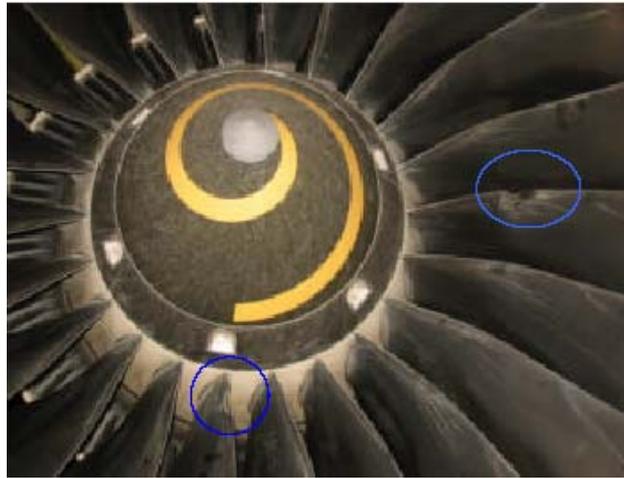
- Three fan blades and cone damage (Figure 1.12-7, 8) ;
- 5 damage locations noted on the LH Nose cowl (four on the inner surface and one external) (Figure 1.12-9, 10) .

Figure 1.12-7 Fan damage

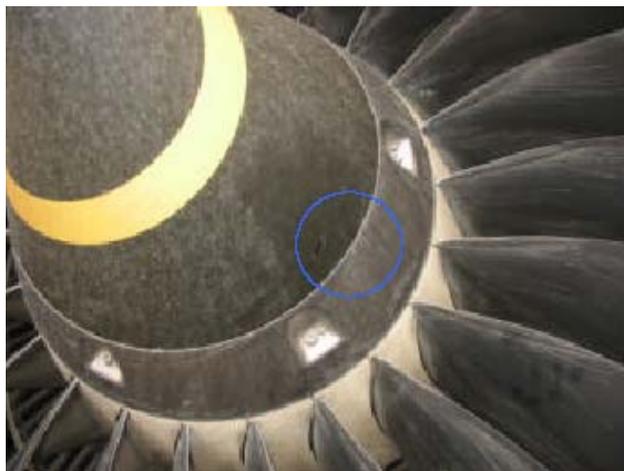
Figure 1.12-8 Cone scratch

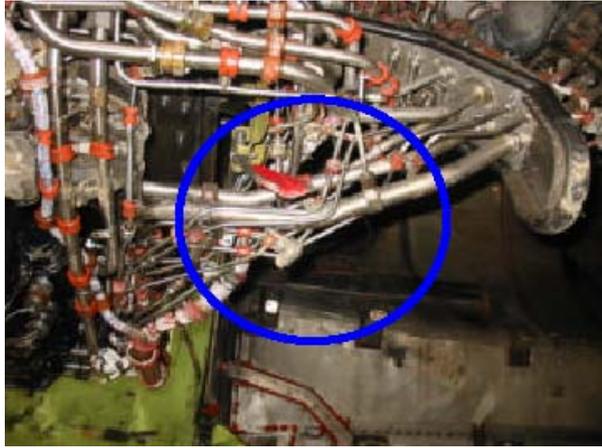
Figure 1.12-13 Bent Pipes, lower drain missing

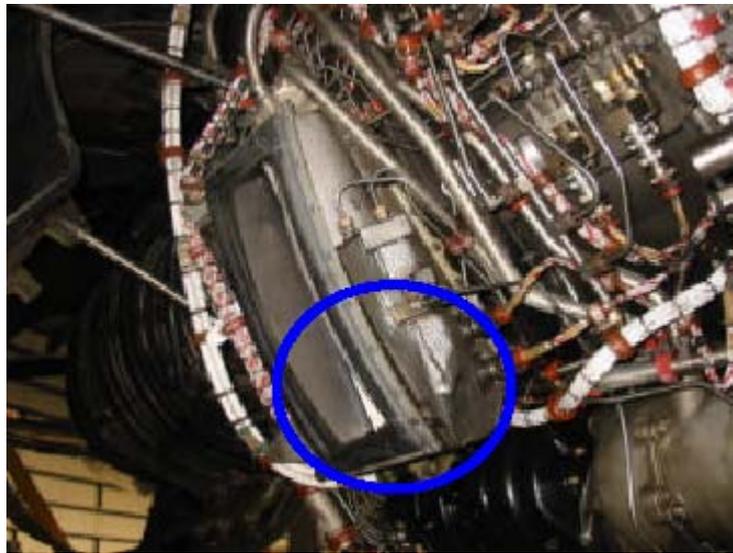
Figure 1.12-14 Lateral cooler damaged

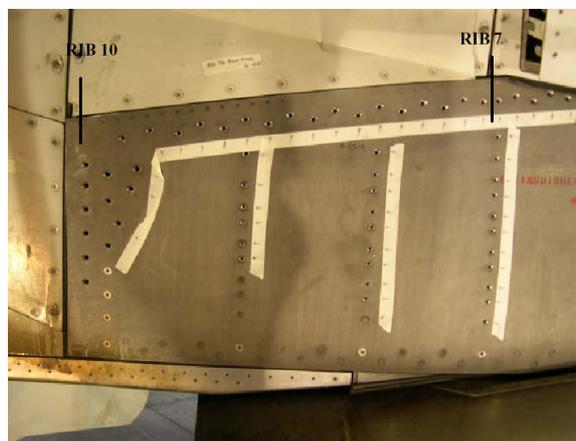
- No visible damage to the attachment points.
- Lateral panel deformation and fastener pulling (Figure 1.12-16) .
- Upper panel deformation/ fastener pulling (Figure 1.12-17~20)
- Closing panel and fairing damage (Figure 1.12-21) .
- Cantilever deformation (Figure 1.12-22)

Figure 1.12-16 Lateral Panel Pulled fasteners

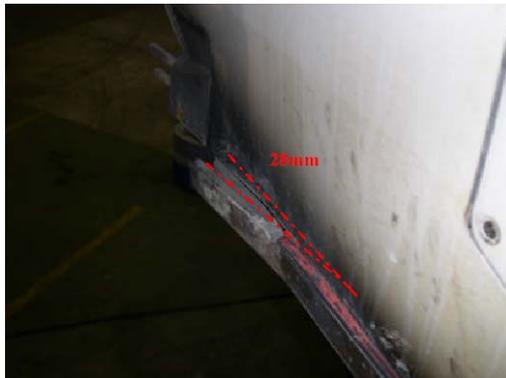
Figure 1.12-19 Twisting of the lower profile

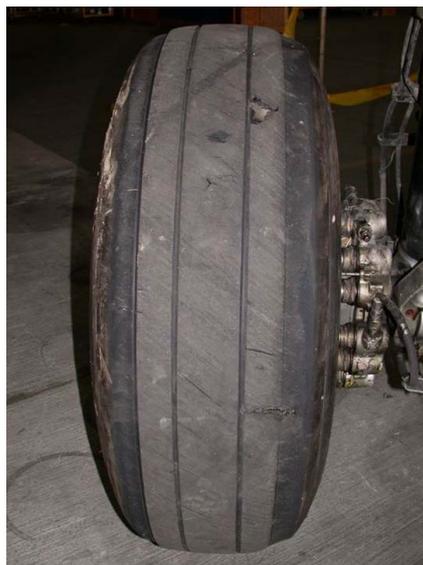
All four tires had deep cut damage (depth up to tread reinforcing ply) and diagonal scratch marks, as shown in Figure 1.16-1. There is no tread rubber reversion present.

Figure 1.16-1 Deep cut damage and diagonal scratch marks

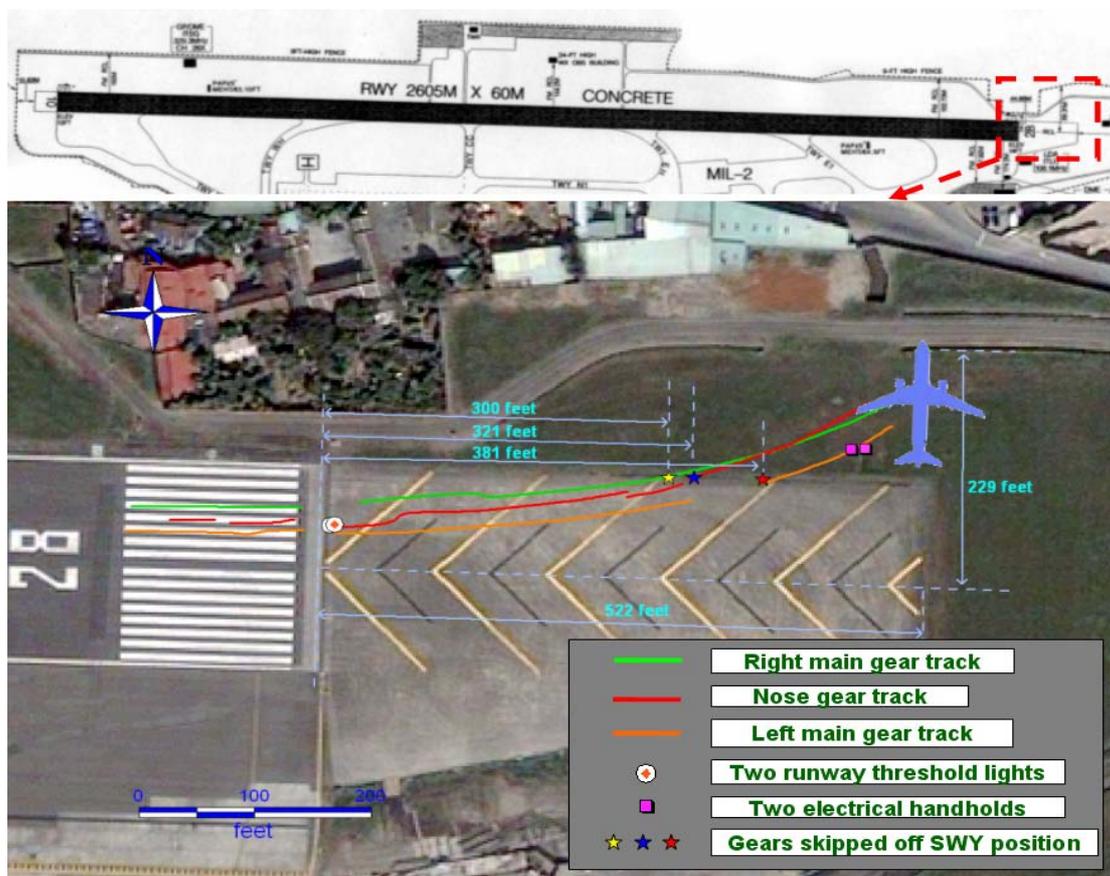
Figure 1.18-1 Sunghshan airport chart and site-survey results with the satellite image

According to the site-survey result, the nose gear of the occurrence aircraft skipped off the pavement of the stopway at 321 feet outward the threshold of Runway 28. The nose gear stopped in the uncovered ditch at about 130 feet in the north of the stopway (Figure 1.18-2). The aircraft stopped with heading 002 and nose downward slightly.

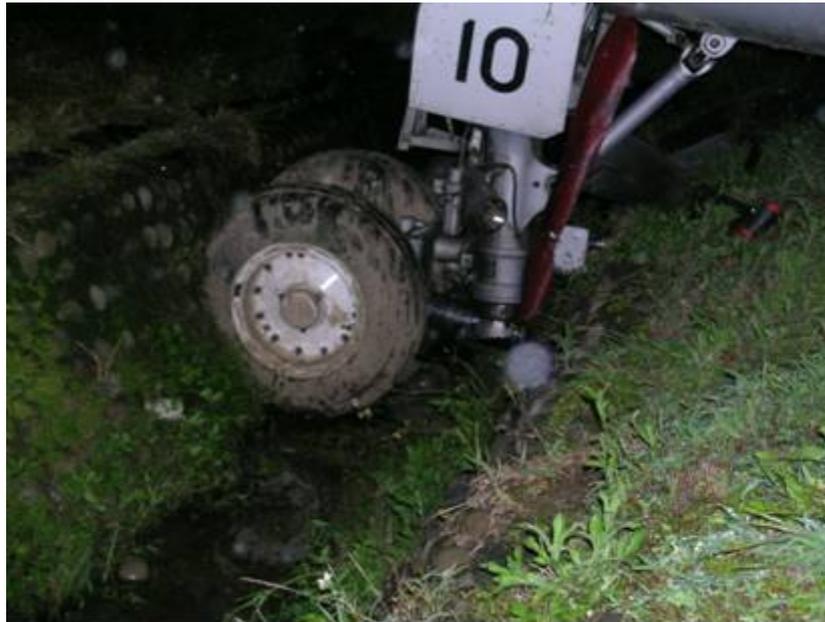
Figure 1.18-2 The nose gear stopped in the ditch

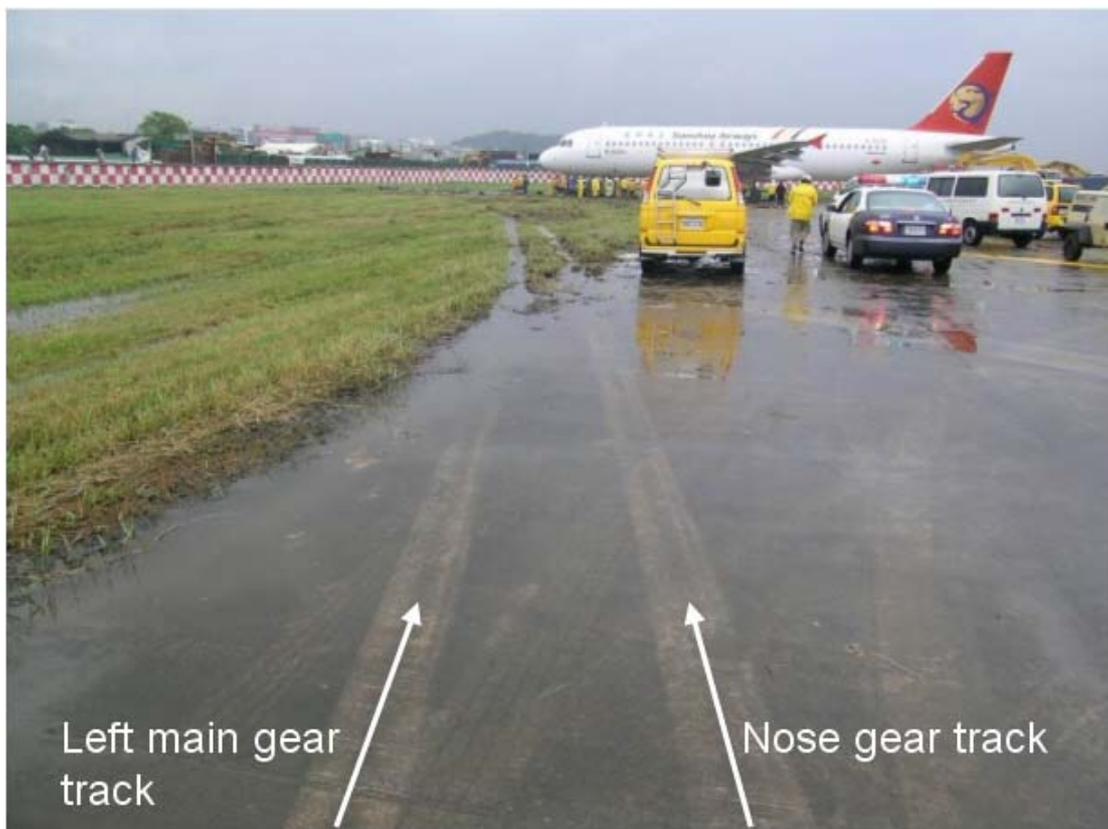
The tire marks of the aircraft could be tracked from the grass area, via the pavement of the stopway, continuously to the runway threshold markings of Runway 28 (Figure 1.18-3). No apparent tire marks of the occurrence aircraft could be found on the runway.

Figure 1.18-3 Ground tracks from the stopway pavement to the grass area
