Runway collision of USAir Flight 1493, Boeing 737 and Skywest Flight 5569 FairChild Metroliner, Los Angeles International Airport, Los Angeles, California, February 1, 1991

Investigative Body: National Transportation Safety Board (NTSB), USA

AIRCRAFT ACCIDENT REPORT

**RUNWAY COLLISION
OF USAIR FLIGHT 1493, BOEING 737
AND SKYWEST FLIGHT 5569 FAIRCHILD METROLINER
LOS ANGELES INTERNATIONAL AIRPORT
LOS ANGELES, CALIFORNIA
FEBRUARY 1, 1991**

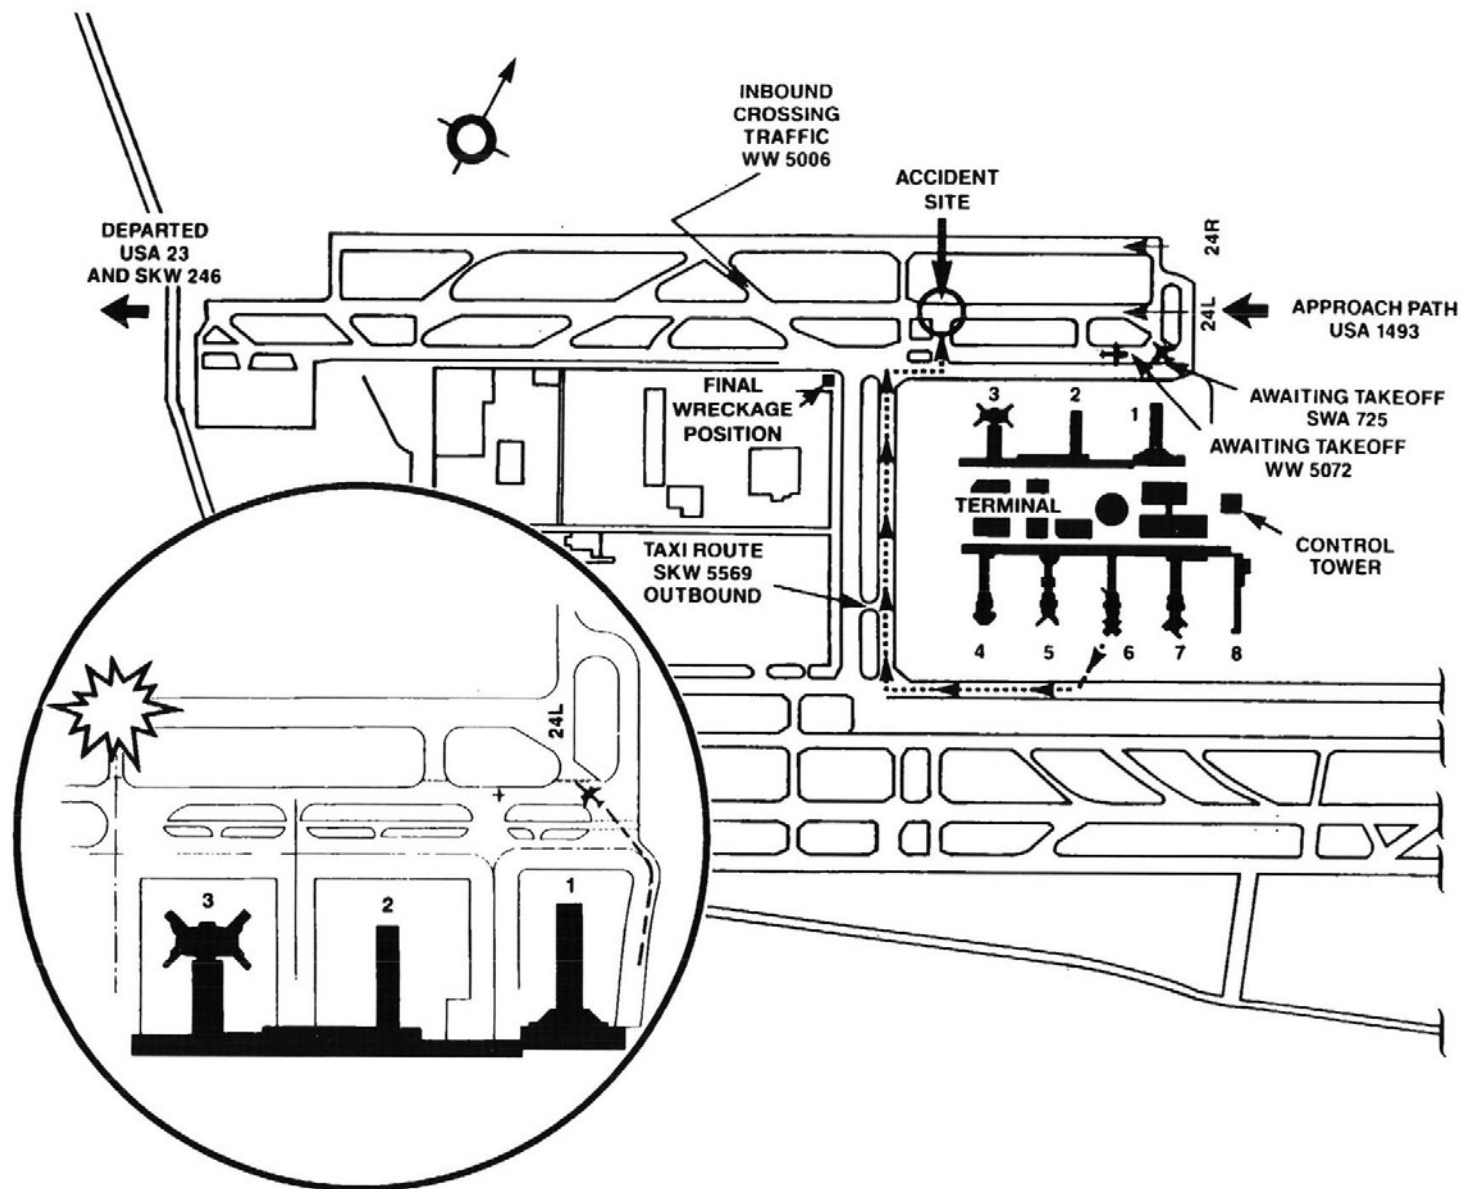
Figure 3.--Airport layout with traffic movements.

About 5 minutes earlier, around 1758, SKW5569 had begun to taxi via the north route from Terminal 6, Gate 32 to runway 24 left for departure (See figure 3). At 1801:43, SKW5569 advised the ATC tower's north ground controller (GC2) "...number two at [taxiway] Tango behind an Aero Mexico airplane." At 1801:49, the GC2 advised SKW5569, "...roger, hold short Tango for right now, Aero Mexico will be moving in just a minute."

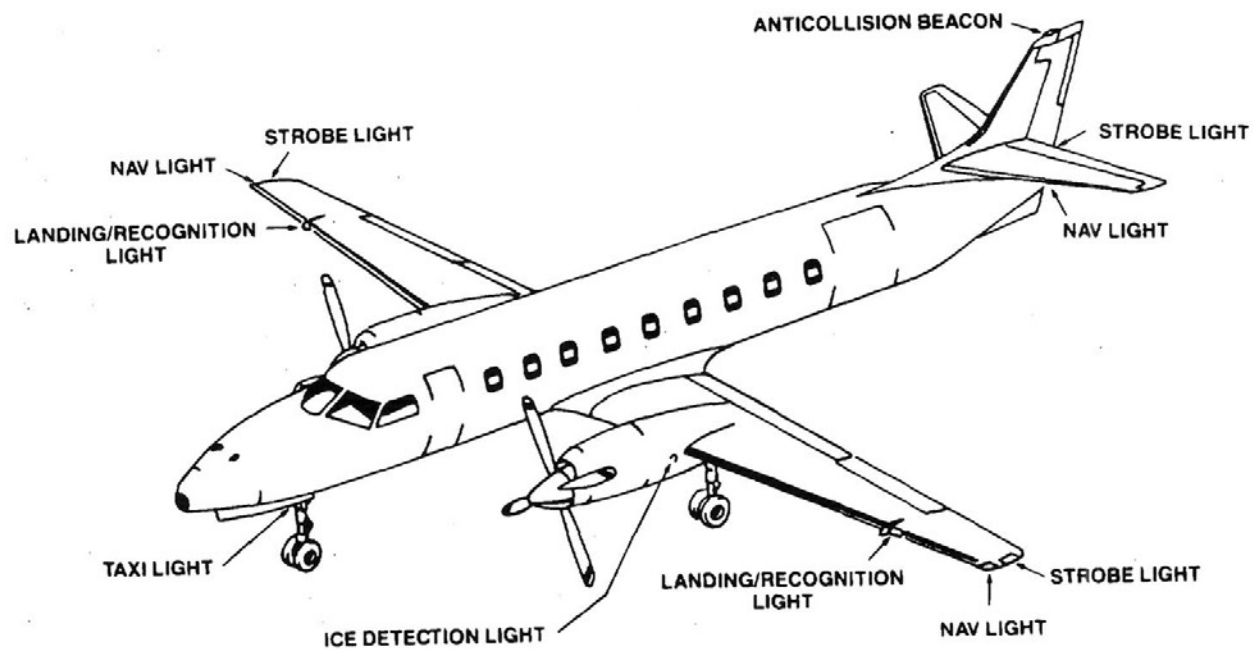
Figure 4.--Metroliner external lighting.

External lighting on N683AV consisted of navigation lights, landing/recognition lights, a taxi light, ice detection lights, strobe lights, and a red anticollision beacon (See figure 4). The beacon light assembly is located on top of the vertical stabilizer forward and below the rudder cap and rudder trailing edge (See figure 5). The location of the beacon light relative to the rudder cap results in some light obstruction; 14 CFR Part 23 permits such obstruction. The rudder cap blocks visibility of the light to an angle of 5.4 degrees above the horizontal and 2.6 degrees left and right of the centerline directly to the rear of the airplane. The beacon light luminance for certification was a candle power of 100 candles; actual luminance was 110 candles.
