NATIONAL TRANSPORTATION SAFETY BOARD

AIRCRAFT ACCIDENT REPORT

IN-FLIGHT ICING ENCOUNTER AND LOSS OF CONTROL
SIMMONS AIRLINES, d.b.a. AMERICAN EAGLE FLIGHT 4184
AVIONS de TRANSPORT REGIONAL (ATR)
MODEL 72-212, N401AM
ROSELAWN, INDIANA
OCTOBER 31, 1994

VOLUME 1: SAFETY BOARD REPORT

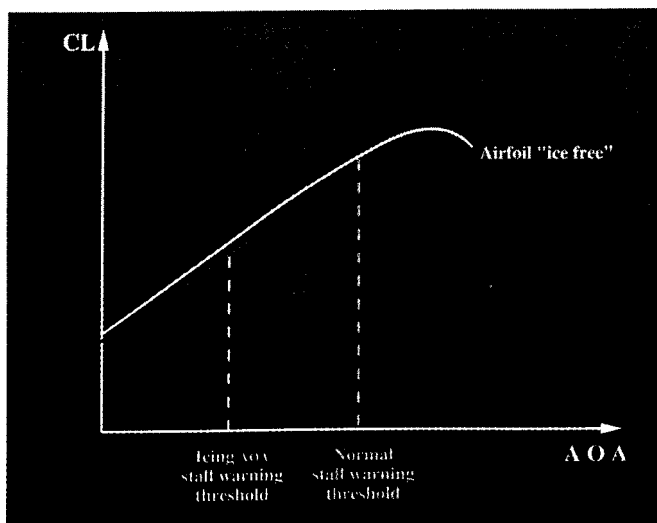
Fig. 12

Stall occurs at higher speeds (fig. 12) when ice accretion spoils the airfoil, therefore the stall warning threshold must be reset to a lower value of angle of attack.

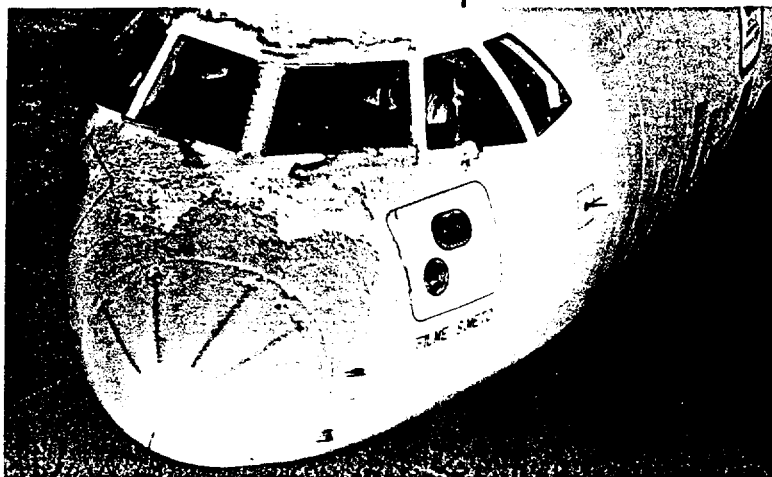
180 Micron Exposure

Ice Evidence Probe

The maximum lateral forces noted, even with the asymmetric ice accretion, were approximately 35-to-40 pounds.
