Wheels-up Landing, Continental Airlines Flight 1943, Douglas DC-9, N10556, Houston, Texas February 19, 1996

Investigative Body: National Transportation Safety Board (NTSB), USA

AIRCRAFT ACCIDENT REPORT

WHEELS-UP LANDING
CONTINENTAL AIRLINES FLIGHT 1443
DOUGLAS DC-9 N10556
HOUSTON, TEXAS
FEBRUARY 19, 1996

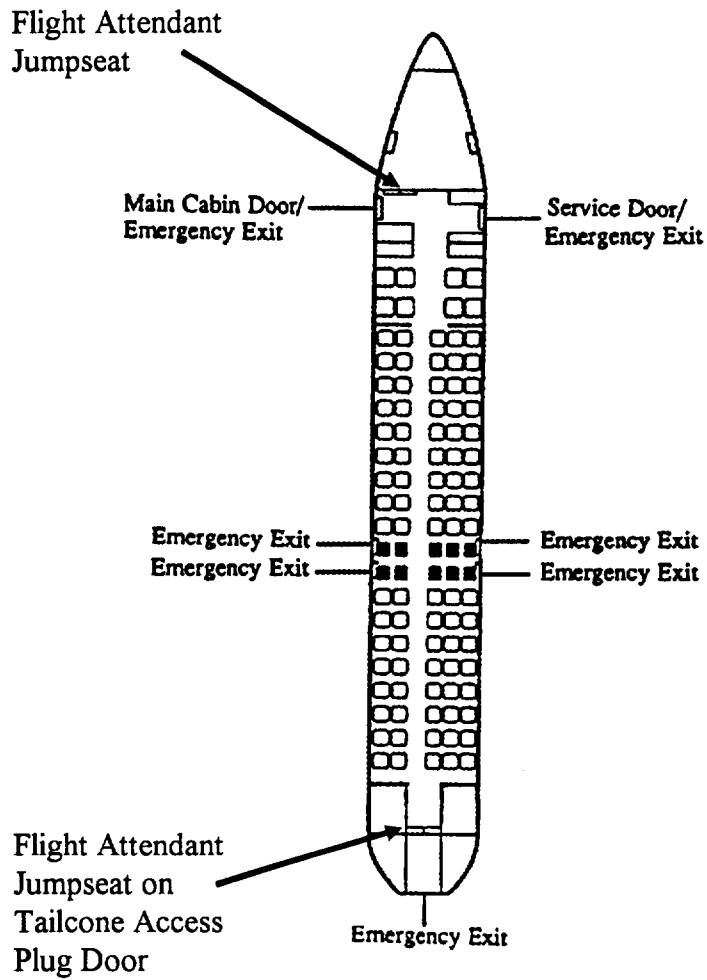
Figure 3 – Cabin configuration.

Two floor-level exits were located in the forward cabin, four overwing exits were located at seat rows 15 and 16, and a tailcone exit was located at the rear of the cabin. (See figure 3.) Access to the tailcone was provided by a plug-type door in the center of the aft cabin bulkhead.²⁹ With this type tailcone access door, the shoulder harnesses for the flight attendants occupying the aft jumpseat are mounted to the plug door, and the flight attendant lap belts are attached to the aft cabin bulkhead. If one or more of the jumpseat shoulder harness straps are buckled to the lap belt, this ties the plug door to the bulkhead and interferes with the removal of the door during an emergency evacuation.

²⁹ COA operates DC-9 airplanes with access to the tailcone exit via either a plug-type door or a floor-level door. At the time of the accident, COA operated two airplanes with the plug-type tailcone access door: one of these was the accident airplane and the other was ship #557.

Subsequent to the accident, on September 16, 1996, COA issued “Inflight Safety Bulletin #96-07” to all flight attendants. The subject of the bulletin was the “Aft Jumpseat Harness on DC-9 Ship #557 (Plug Door).” The bulletin provided information on how to prevent blocking a useable exit during an evacuation. It emphasized the need to fully rotate the release knob when unfastening the jumpseat restraining harness to ensure that the shoulder straps release and cautioned flight attendants never to leave the shoulder harness attached to the seat belt. On October 16, 1996, COA issued a revision to the Inflight Manual that included the following note concerning the plug door:
