# Crash During Landing, Federal Express, Inc., McDonnell Douglas MD-11, N611FE, Newark International Airport, Newark, New Jersey, July 31, 1997

## AIRCRAFT ACCIDENT REPORT

CRASH DURING LANDING  
FEDERAL EXPRESS, INC.  
MCDONNELL DOUGLAS MD-11, N611FE  
NEWARK INTERNATIONAL AIRPORT  
NEWARK, NEW JERSEY  
JULY 31, 1997

**NTSB/AAR-00/02  
DCA97MA055  
PB2000-910402  
Notation 7047B  
Adopted July 25, 2000**

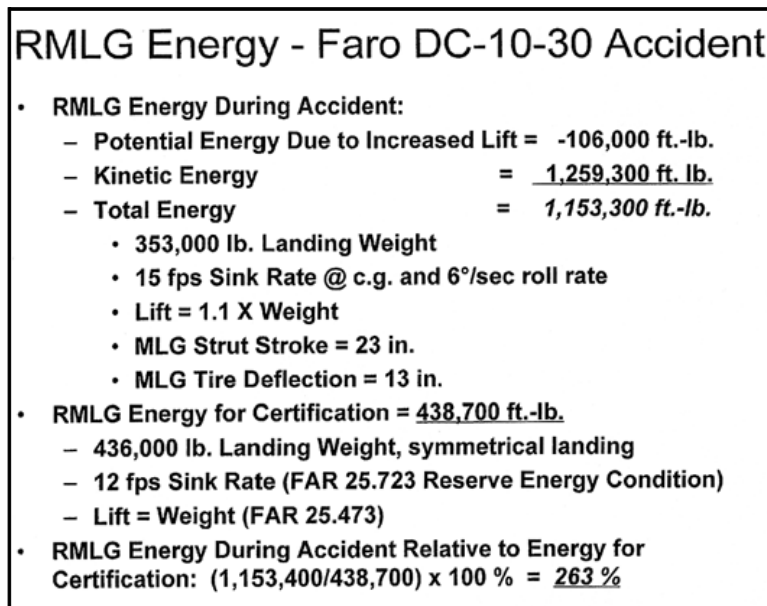
**Figure 10.** Boeing calculations of right MLG energy in the Faro accident.

[A]t a landing weight of 353,000 [pounds], lift at start of touchdown of approximately 1.1 times the aircraft weight, and descent rate at the aircraft [c.g.] of approximately 15 fps and roll rate of 6 [degrees per second], the kinetic energy, 1,259,300 ft-lbs, was decreased by potential energy (from increased lift) by approximately 106,000 ft-lbs, for a total energy of approximately 1,153,000 ft-lbs on the [right] MLG. Comparing the Faro accident energy with the DC-10-30’s [right] MLG energy required for certification shows that the energy developed during the Faro accident landing was over 2 and a half times the reserve energy (ultimate) certification requirements for a single [MLG].

Figure 10 shows Boeing’s calculations of the energy imparted to the right MLG in the Faro accident.

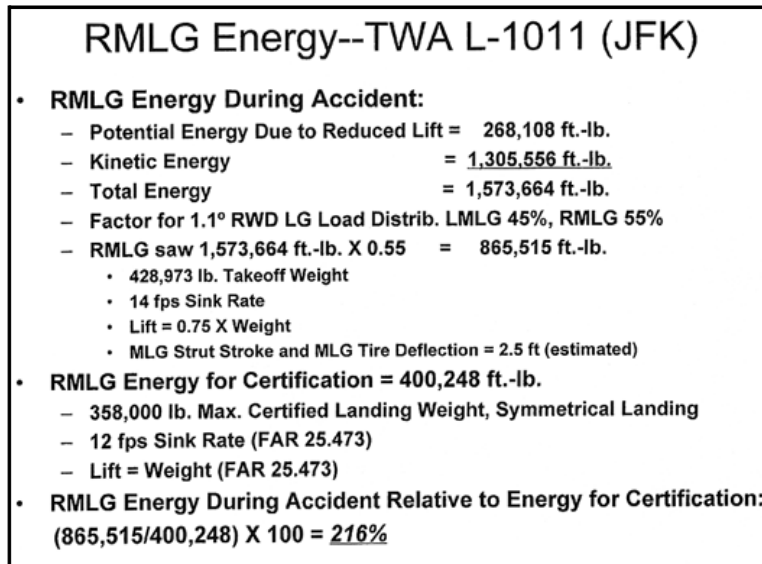
**Figure 11.** Boeing calculations of right MLG energy in the TWA L-1011 accident.

Figure 11 shows Boeing's calculations of the energy imparted to the right MLG in the L-1011 accident.
