**Loss of Pitch Control on Takeoff, Emery Worldwide Airlines, Flight 17,
McDonnell Douglas DC-8-71F, N8079U, Rancho Cordova, California,
February 16, 2000**

Aircraft Accident Report
NTSB/AAR-03/02

**Loss of Pitch Control on Takeoff
Emery Worldwide Airlines, Flight 17
McDonnell Douglas DC-8-71F, N8079U
Rancho Cordova, California
February 16, 2000**

The National Transportation Safety Board determined that the probable cause of the accident was a loss of pitch control resulting from the disconnection of the right elevator control tab. The disconnection was caused by the failure to properly secure and inspect the attachment bolt.

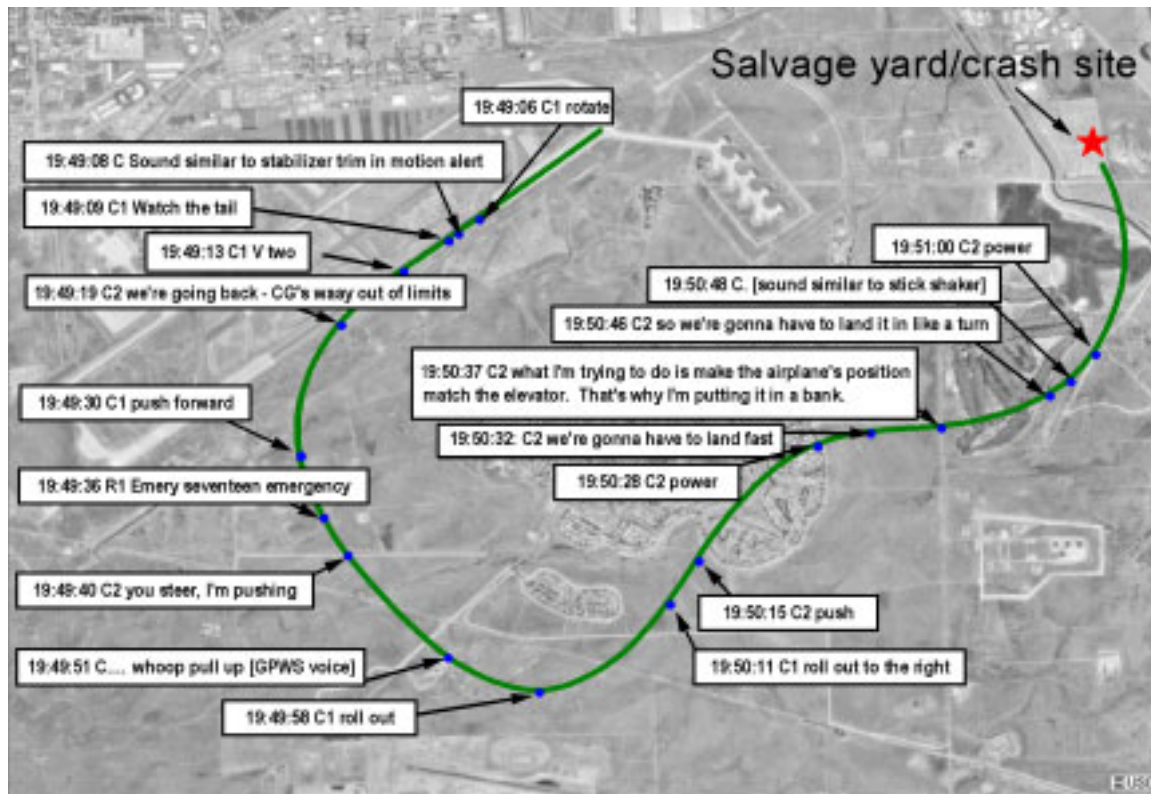
The airplane impacted the ground in a left-wing-low, slightly nose-up attitude in an automobile salvage yard, about 1 mile east of the departure runway. Figure 1 shows the airplane’s ground track, with selected CVR comments, during the accident flight. (For additional information regarding CVR comments, see the CVR transcript in appendix B).

Figure 1. The airplane's ground track, with selected CVR comments, during the accident flight.

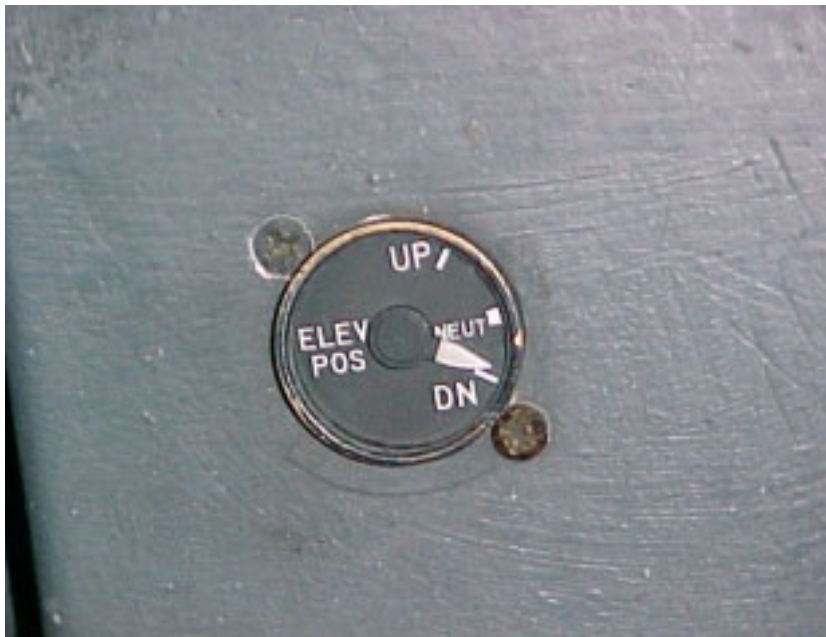
The DC-8 EPI is a 1-inch diameter circular cockpit gauge with a pointer needle and index markings for UP, DN (down), and NEUT (neutral) positions to indicate the position of the elevators. When the EPI is properly calibrated, the up index mark should correspond to the maximum TEU elevator surface position of 27° and the down index mark should correspond to the maximum TED elevator surface position of 16.5° TED. A narrow white band adjacent to the NEUT index mark indicates an elevator surface position between 0° and 5° TEU. Figure 3 is a photograph of an EPI gauge similar to that on the accident airplane.

Figure 3. A photograph of an EPI gauge similar to the gauge installed on the accident airplane.

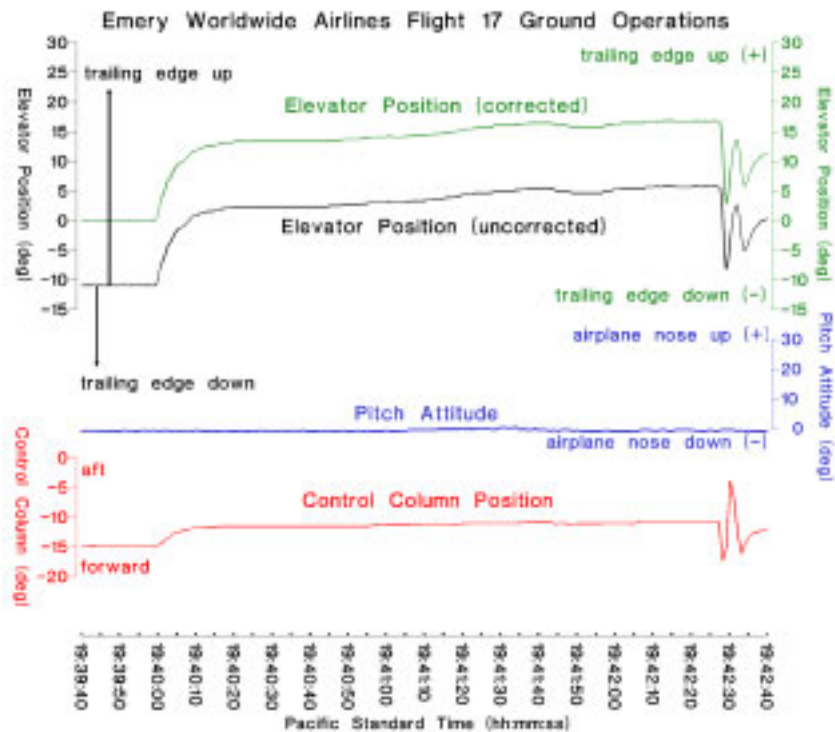
Figure 6 shows the elevator, pitch, and control column plots recorded by the accident airplane's FDR during ground operations before the accident flight. On this plot, the uncorrected data on the far left side of the plot shows an 11° TED elevator deflection when the gust lock was engaged (and the elevator was in its neutral, or 0°, position).

Figure 6. Elevator, pitch, and control column plots recorded by the accident airplane's FDR during ground operations before the accident flight. The first 20 seconds of data were recorded while the gust lock was engaged.

The Safety Board's examination of the corrected elevator position data revealed that the airplane's elevator never traveled below its neutral position to a TED deflection during the accident flight, although recorded forward control column inputs should have resulted in a TED elevator deflection. For example, although the FDR data indicated that, during the 80-knot elevator check at MHR, the control columns were moved to about 6° forward of their rigged neutral position, the elevators did not deflect below 2.2° TEU. In contrast, during the 80-knot elevator check on the previous takeoff (at RNO) the FDR recorded elevator movement to 8° TED, with less forward control column movement. Figure 7 shows plots of the pitch attitude, control column position, and elevator position FDR data for the accident flight. Elevator position is shown using the conversion that corrected for the 11° offset. Figure 7 also shows when the 80-knot elevator check and takeoff occurred. Figure 8 shows the same information for the takeoff from RNO.

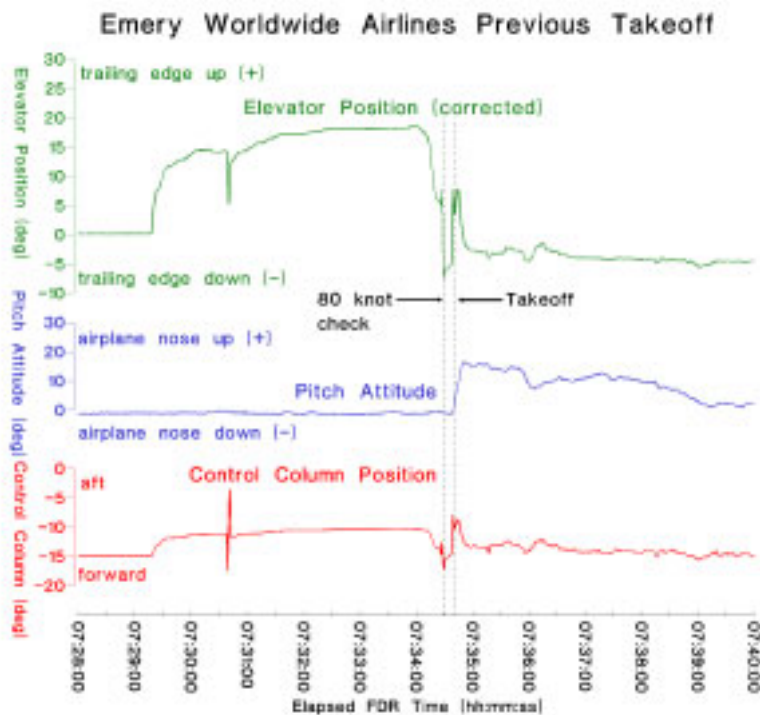
Figure 8. Pitch attitude, control column position, and (corrected) elevator position FDR data for the previous takeoff from RNO. About the first 1 minute 20 seconds of data were recorded while the gust lock was engaged.
