Airspace incident between ATR 72-212 ZK-MCC and Boeing 737-219 ZK-NAT, Queenstown control zone, 26 July 1999

Report 99-005

ATR 72-212 ZK-MCC and Boeing 737-219 ZK-NAT

airspace incident

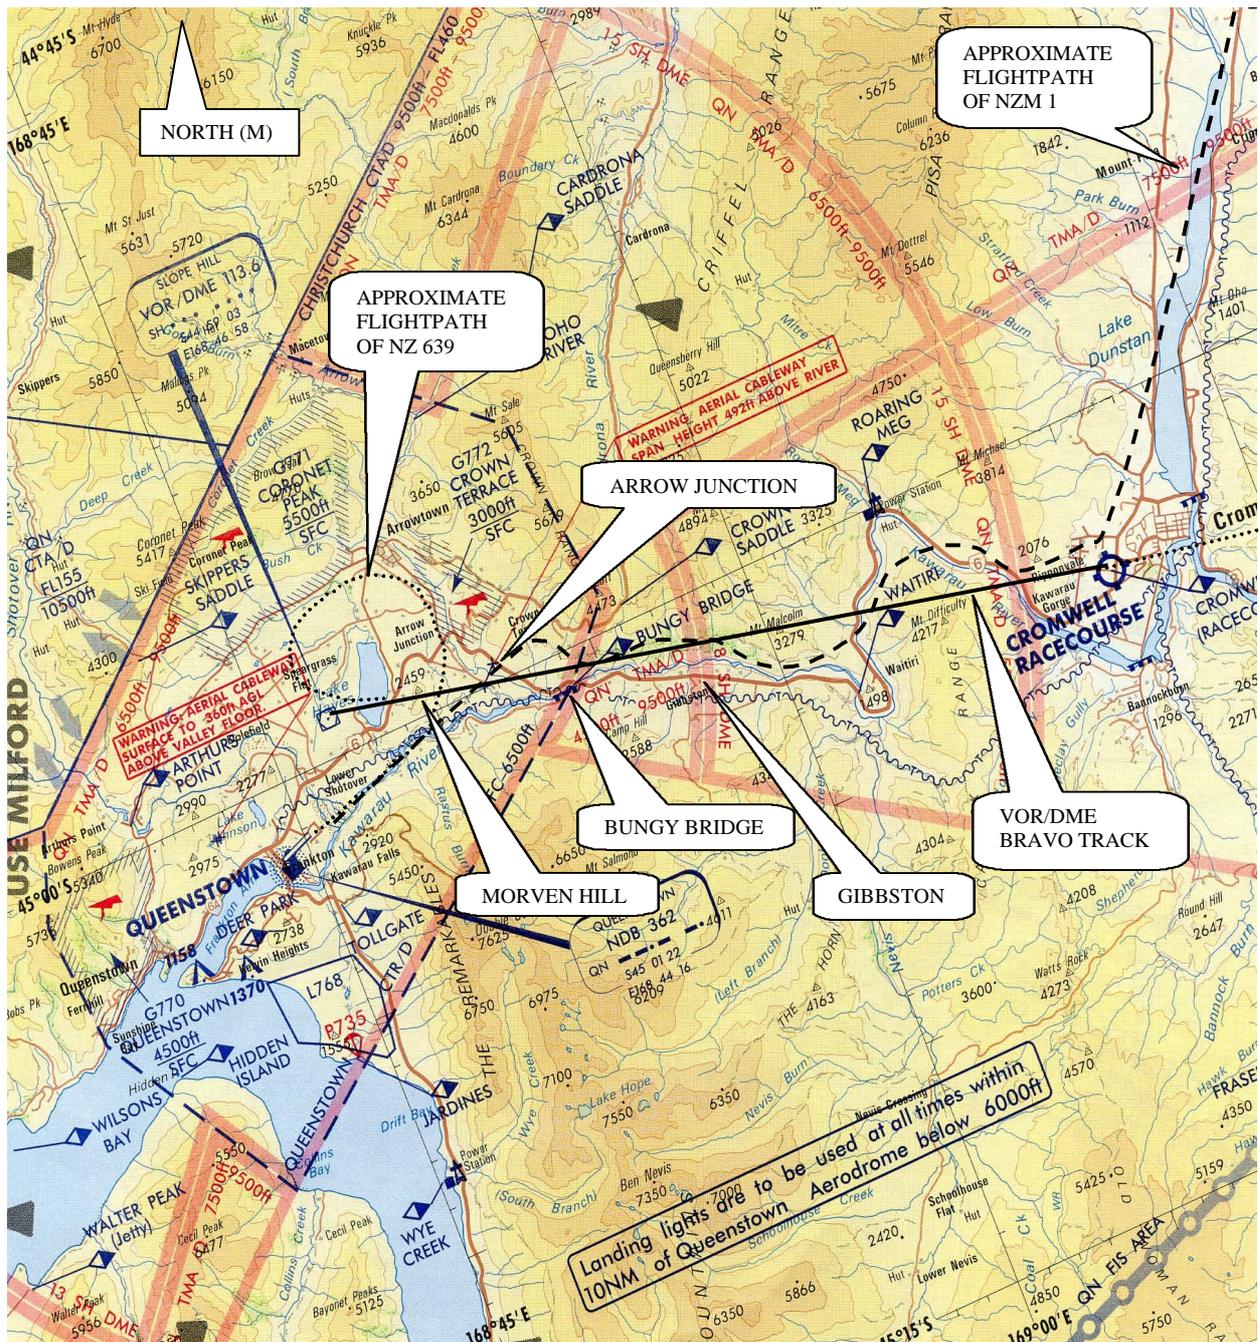
Figure 1
Queenstown Visual Terminal Chart
effective 15 July 1999 (not to scale)

- 1.5.2 To address concerns over possible delays, VFR entry and exit routes and procedures were established. Where practicable these new routes and procedures followed those traditionally flown by VFR traffic. Further, 3 local general aviation areas (GAAs) were also established in an effort to identify and contain activities such as parapenting and hang-gliding. The GAAs, G770, G771 and G772 (see Figure 1), were each located within the Queenstown CTR and designated as active during daylight hours, for the purpose of facilitating VFR operations. Queenstown GAA users did not require the approval of, or communication with, ATC before operating in the areas, but any radio communications were to be on the Queenstown Tower frequency of 118.1 MHz. Because of the GAAs’ distance from Queenstown Tower and some intervening terrain, controllers could not always confirm when the areas were being used. G772 was located on the Crown Terrace in a direct line between Bungy Bridge and Arrowtown, extending from the surface to 3000 feet above mean sea level (amsl) or up to about 1700 feet agl.

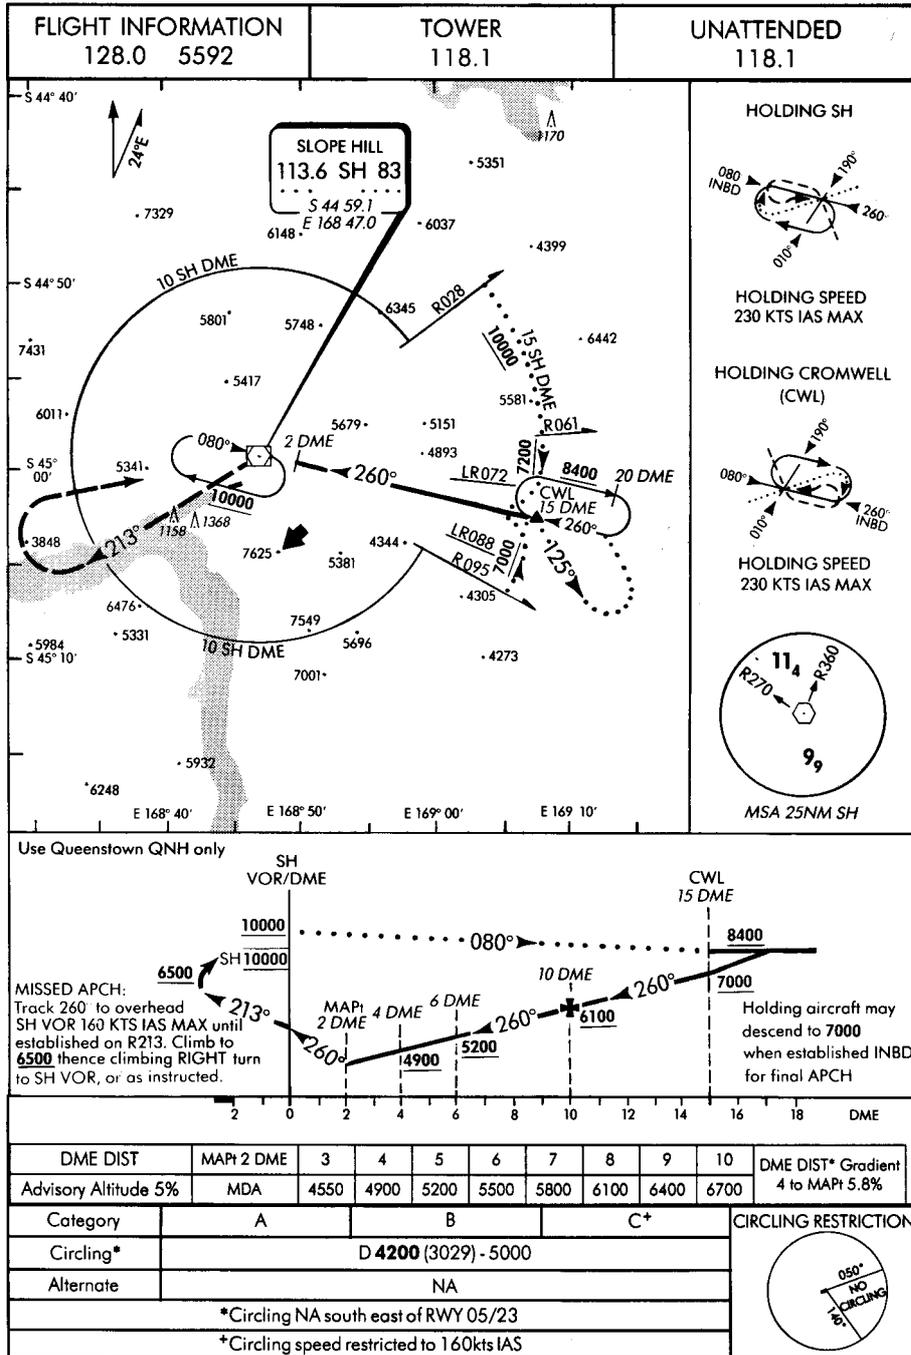
QUEENSTOWN
VOR/DME BRAVO

ELEVATION 1171

- 1.1.5 By 1208 hours NZ 639 had commenced descent to Queenstown and was cleared by Queenstown Tower (Tower), through Information, to join the 15 nm VOR/DME arc for the Bravo approach circling for runway 23. A slight deterioration in weather was reported by Information. Once established on the arc the first officer changed to the Tower frequency of 118.1 MHz. The aerodrome controller manning the Tower position confirmed there had been no further change in the weather since the last report and advised that the visibility towards Bungy Bridge visual reporting point (see Figure 1) was 8 km, but better towards Lake Hayes with 10 to 15 km. To the south of the aerodrome and over Lake Wakatipu there was a solid main cloud base between 2500 and 3000 feet above ground level (agl).
