Jetway collision with airliner, Boeing 747-286B, EP-IAH, London Heathrow, June 20, 2002

Micro-summary: This Boeing 747 was struck by a jetway prior to departure.

Investigative Body: Aircraft Accident Investigation Board (AAIB), Great Britain

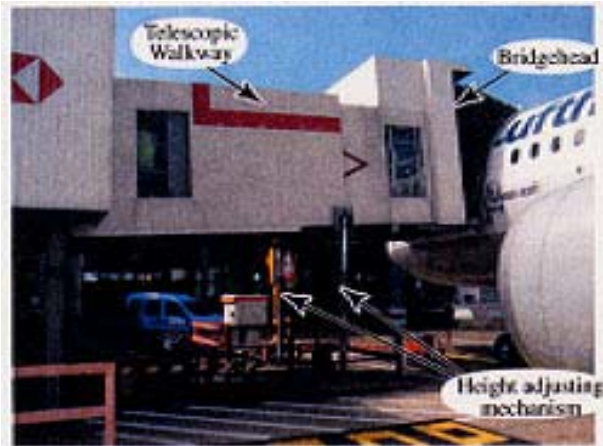
a) Rail-drive (see Figure 1 Plate 1)

Plate 1 Rail-drive airbridge

This type consists of a relatively short, telescopic pedestrian tunnel which projects from a fixed access walkway and is orientated at right angles to the centreline of the aircraft stand which it serves. The inner end of the airbridge is hinged on the fixed walkway to allow the airbridge head, which abuts the aircraft, to be raised or lowered to suit the door sill height of any aircraft type permitted to use the particular stand. The telescopic portion extends beyond the height adjusting mechanism, which is mounted on a fixed base on the apron, and, when fully retracted, is well clear of the fuselage of an aircraft on the stand. This type of airbridge cannot be moved laterally relative to the aircraft's side and so, on stands with this type of airbridge, aircraft must park in a precise position, according to their specific type and model. The airbridge extension and head height are controlled from a console at the airbridge head which is orientated in the same direction as the airbridge.

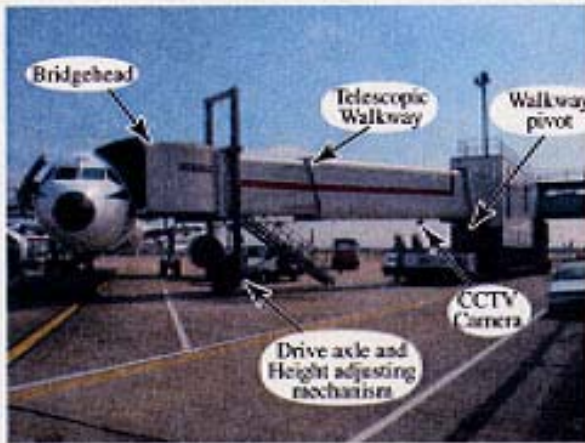
Plate 2 Older type apron-drive airbridge

Of the 'Apron-drive' airbridges in Terminals 2 & 3, where the controller involved in this incident worked, all of those in Terminal 2 and the majority in Terminal 3 are of one make and have been in service for several years (see Figure 1 Plates 2 & 2a). These are controlled from a console in the airbridge head and have the steerable drive axle and height adjusting mechanism just behind the airbridge head; the drive axle steering has limiting switches fitted in the mechanism. The control console faces forward, which gives the controller a direct view out of the front of the bridge towards an aircraft on the stand; there are no side windows. The drive and/or steering can be operated manually, from ground level, if power to the bridge is lost or disabled.

Airbridge movement across the apron is controlled by a joystick, which causes movement of the bridgehead in the same direction that the stick is deflected, and there are pushbutton controls for bridge head slew and height. There is an axle position indicator which shows, clearly, the orientation of the drive axle relative to the axis of the airbridge and the direction of 'forward' drive. There is a monitor with adjustable brightness and contrast, but no zoom, to view the image from an apron surveillance CCTV camera. This is mounted on the underside of the airbridge walkway, back near the pivot, and allows the controller to see any obstructions on the apron area around the drive axle and is used to position the airbridge wheels in their parking 'box' when it has been drawn back from an aircraft on the stand. This was the type of airbridge with which the controller involved in this incident was familiar.

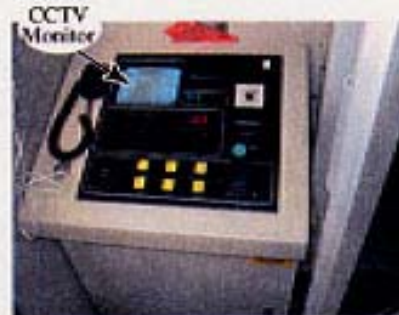
Plate 2a Control console on older type apron-drive airbridge (faces forwards)
