Pressurization emergency, Boeing 737-548, Aer Lingus, EI-CDB

Micro-summary: An apparent failure of the pressurization system results in a decision to return to the origin airport.

*AAIU Report No.2001-014
AAIU File No. 2000/0064
Date Published: 21 September 2001*

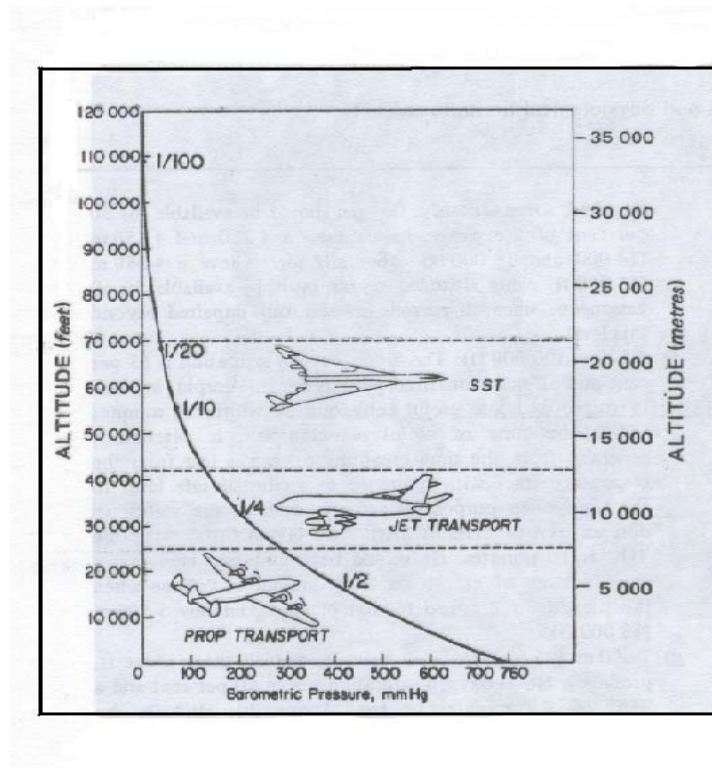
Figure 1

With increasing altitude, there is a decrease in the density of the atmosphere and an exponential decrease in the barometric pressure. Associated with this pressure event are other phenomena such as temperature drop. From a biological viewpoint, the barometric pressure drop is the most specific feature of the altitude climate. The relationship between barometric pressure and operating ceiling of aircraft is shown in Figure 1.

A matter of practical importance is that barotraumas (bodily effects of changes in barometric pressure) may occur at low altitudes because of the steep slope of the altitude pressure curve at lower levels. Even normal shifts in pressurised cabins can result in barotrauma since descent from only 6,500 ft to sea level entails a pressure differential of 150 mm Hg. The highest rate of barometric change occurs below 10,000 ft.
