Turbulence, Northwest Airlines, Inc., Boeing 747-151, N606US, Over the North Pacific Ocean, 105 Nautical Miles West of 150° East Longitude at 36° North Latitude, April 12, 1972

Micro-summary: Severe clear air turbulence on this Boeing 747 injured several occupants.

Investigative Body: National Transportation Safety Board (NTSB), USA

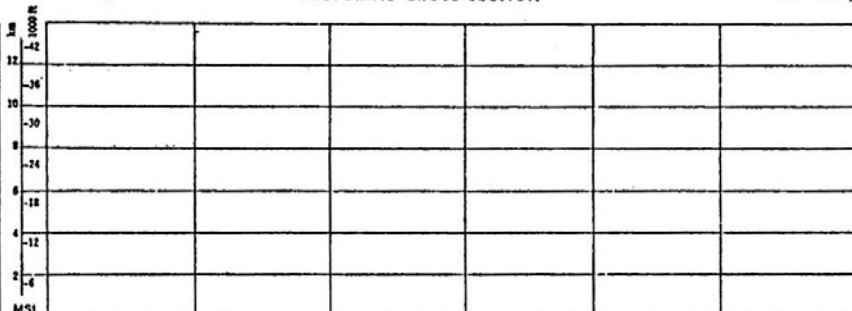
PICTORIAL CROSS-SECTION**

**Information entered on this pictorial cross-section is intended to supplement the observations recorded on this form when, in the opinion of the pilot-in-command, a graphical representation will usefully amplify or assist in clarifying the observations recorded elsewhere on this form.
