## Hard landing, Report on the accident to Boeing MD11 B-150 at Hong Kong International Airport on 22 August 1999

**AIRCRAFT ACCIDENT REPORT 1/2004**

**ACCIDENT INVESTIGATION DIVISION**

**Report on the accident to  
Boeing MD11 B-150  
at Hong Kong International Airport  
on 22 August 1999**

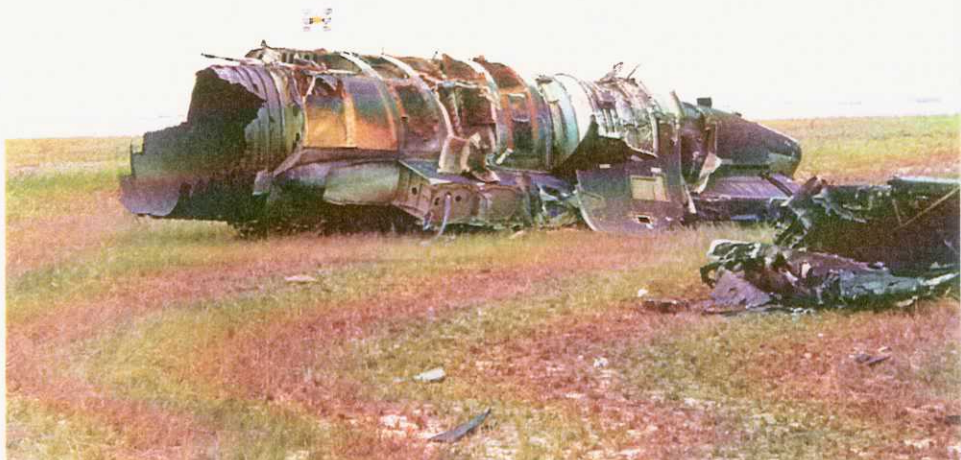
**No.1 Engine (Figure 17)**

### **6.1. No. 1 engine; s/n: 723907 (Figure 17)**

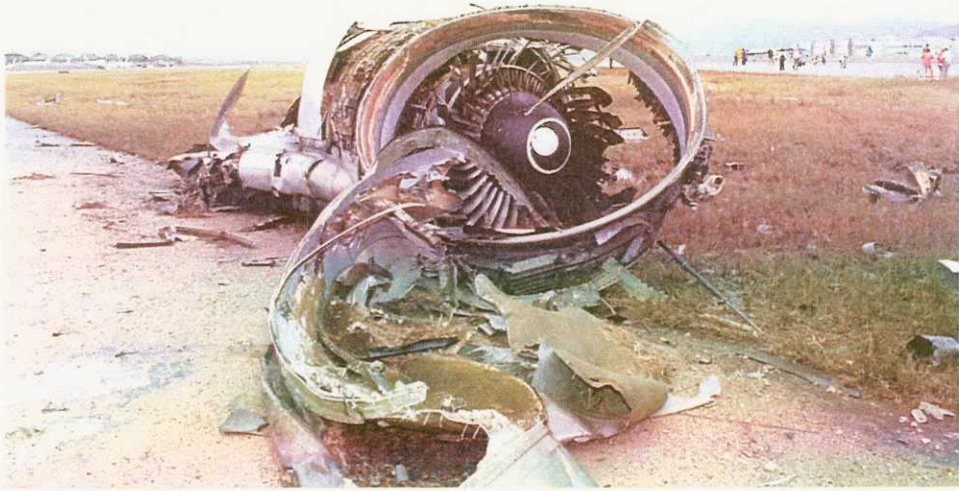
**No.2 Engine (Figure 18)**

**6.2. No. 2 engine; s/n: 723968 (Figure 18)**

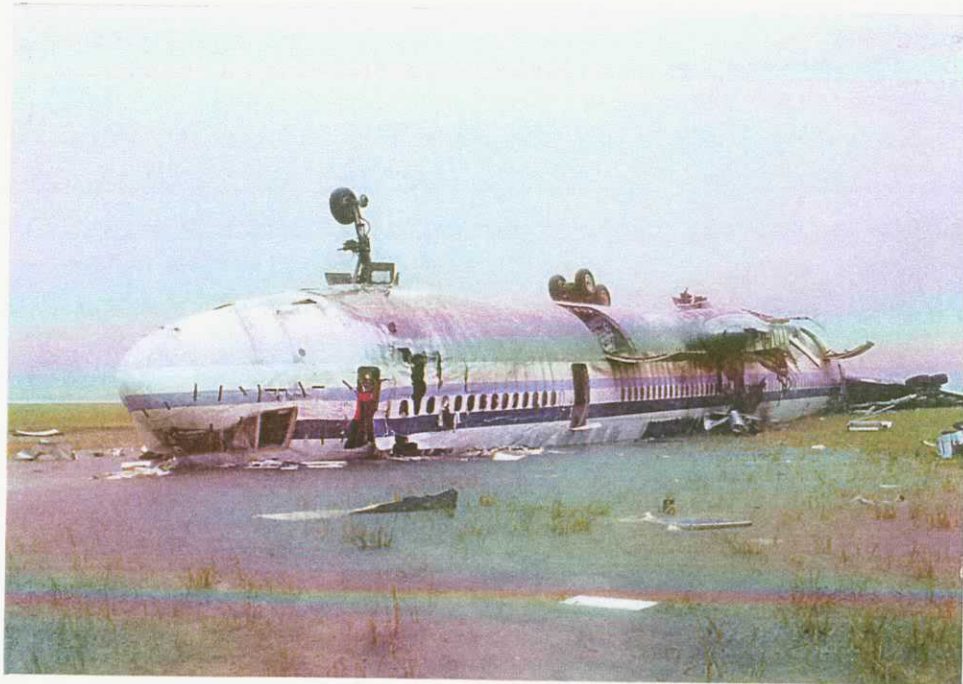
1. General view of main wreckage.

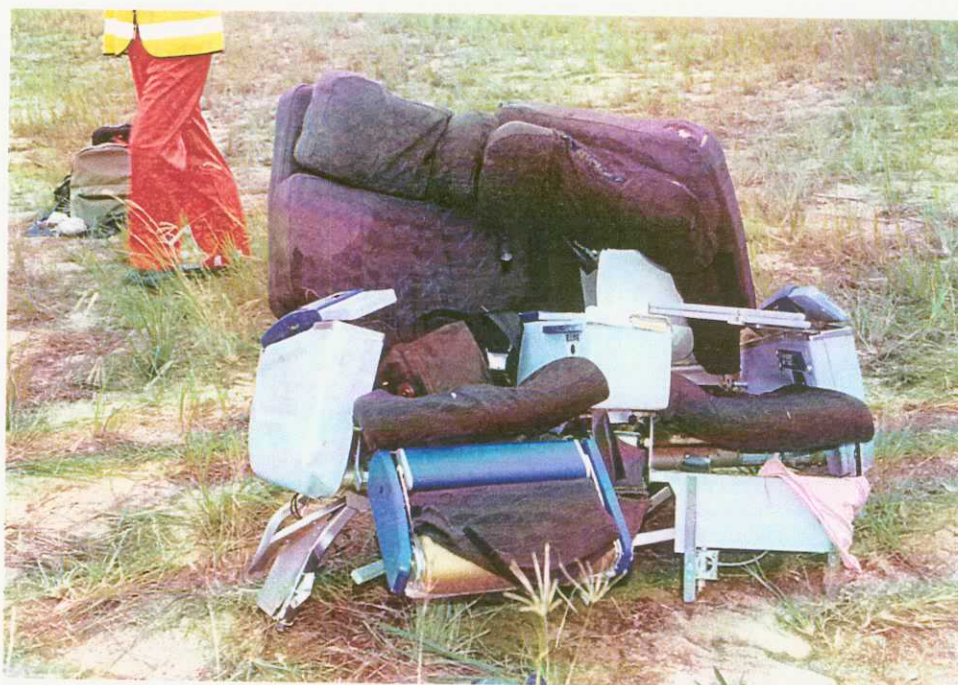
2. View of seats 1J and 1K.

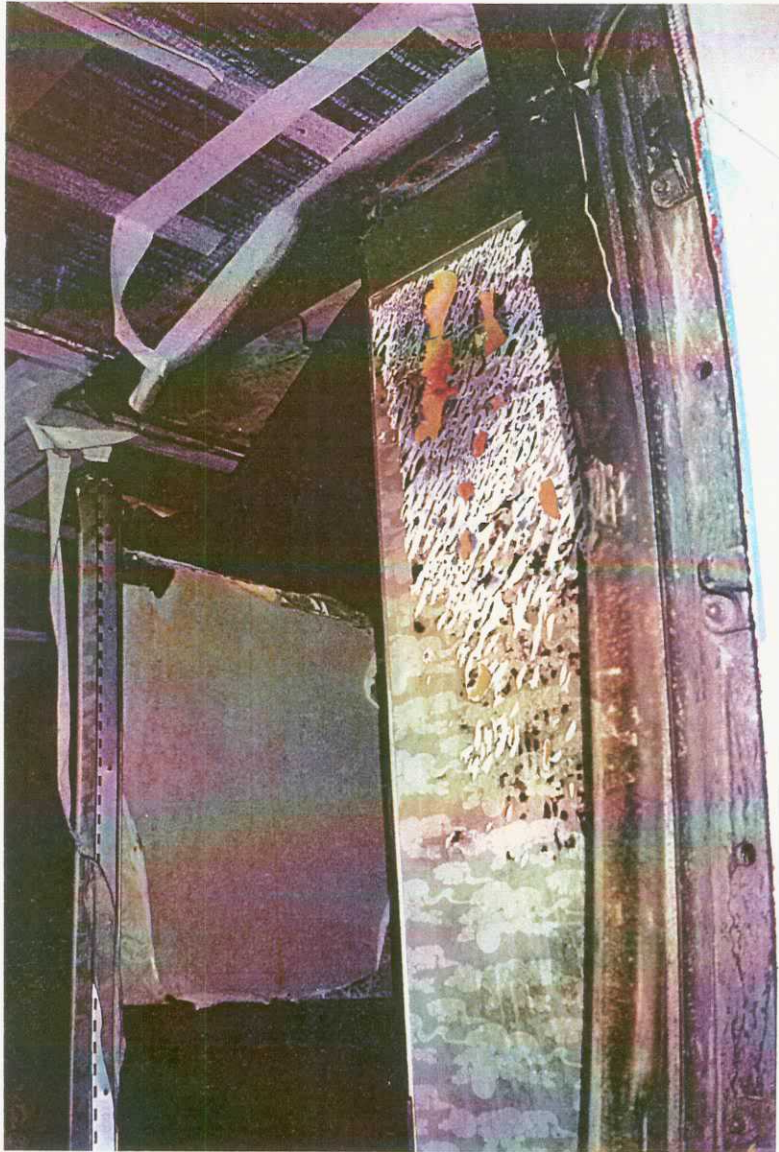
3. View of the lavatory just inside Door 3R.

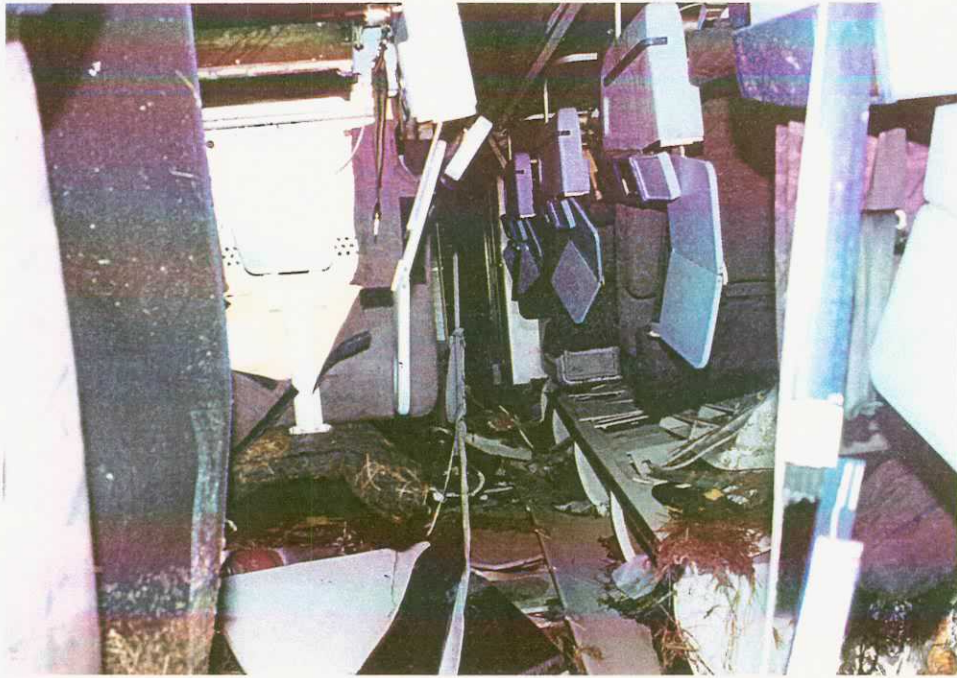
4. View of the Business Class section of the cabin.

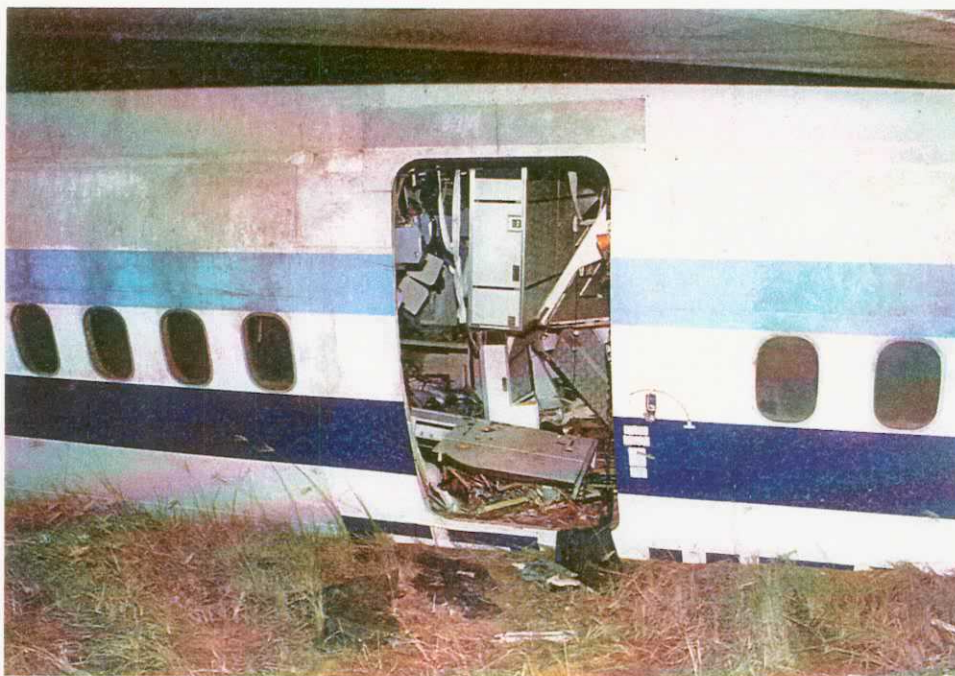
7. View of left side of fuselage including Door 3L.

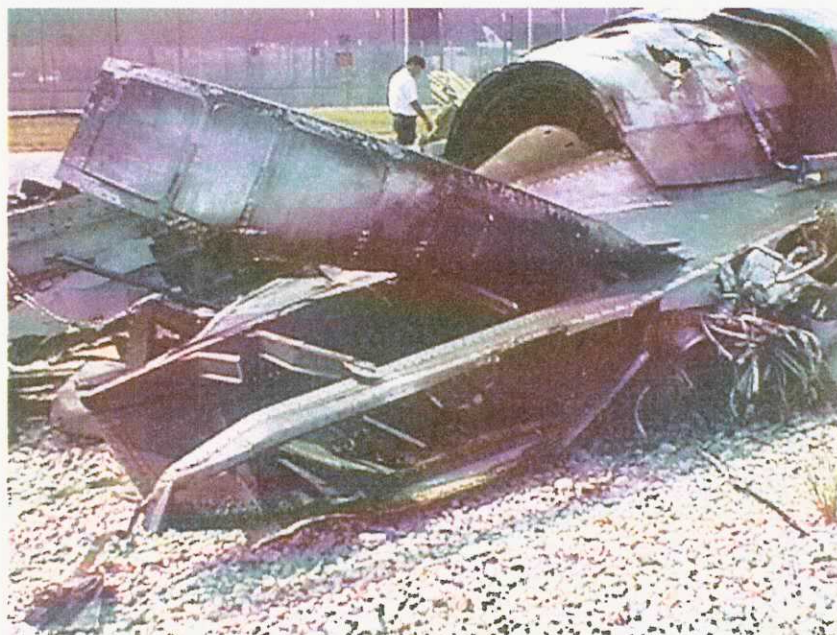
Figure 38. Right engine pylon

Figure 37 shows that the right pylon failure mode was different for the China Airlines accident aircraft; the right engine pylon aft-attach bulkhead is still attached to the right wing. Figure 38 shows the right engine pylon. The observed failures suggest that the loads on the nacelle included a significant sideways

component. This is thought to have occurred because the outboard wing, as the failure progressed, began to sweep further and further aft.
